REPAIR & REHABILITATION OF ROB NANDNAGRI FLYOVER (at Road No. 68), DELHI

CONDITION STATUS REPORT AND REMEDIAL MEASURES ON NANDNAGRI FLYOVER (AT ROAD No.68) - DELHI

CONSTRUMA CONSULTANCY PVT. LTD.

FEBRUARY, 2019

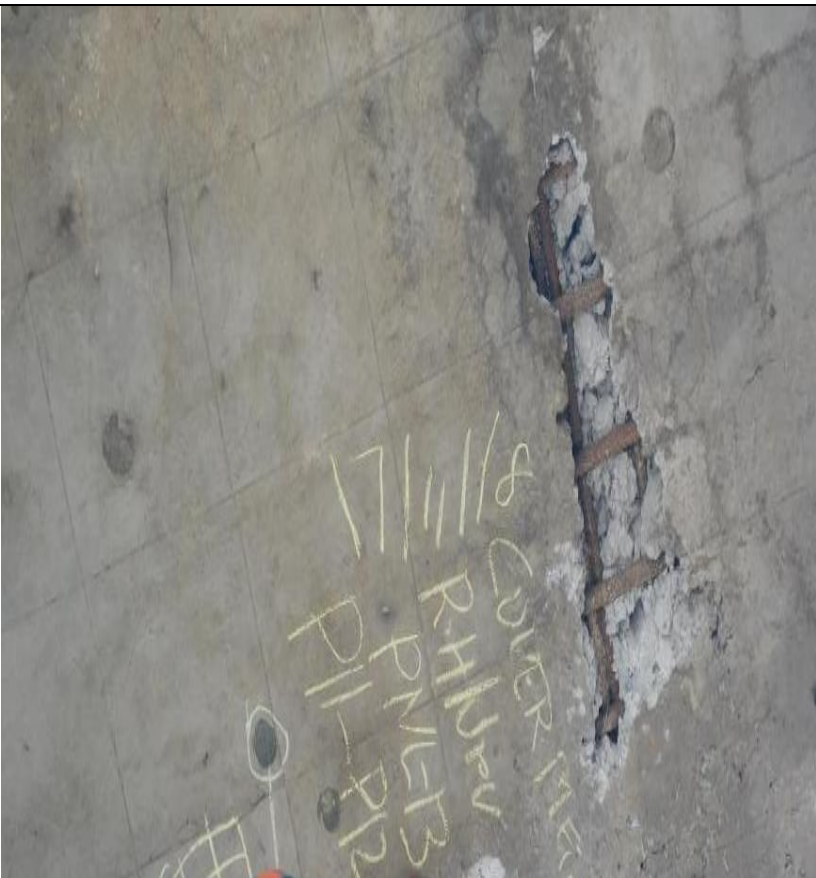
Photo 1

Location	P11-P12 PANEL-13	
	Nature of Distress	Spalling	
	Extent & Severity	Severe	
Photo 2

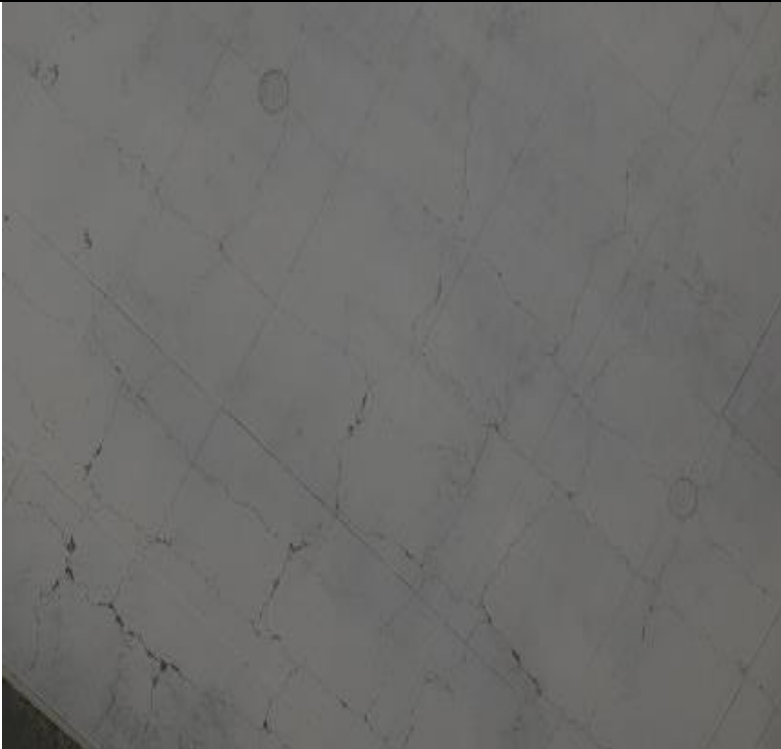
Location	P5-P6 PANEL-3	
	Nature of Distress	Minor & Major Cracks	
	Extent & Severity	Severe

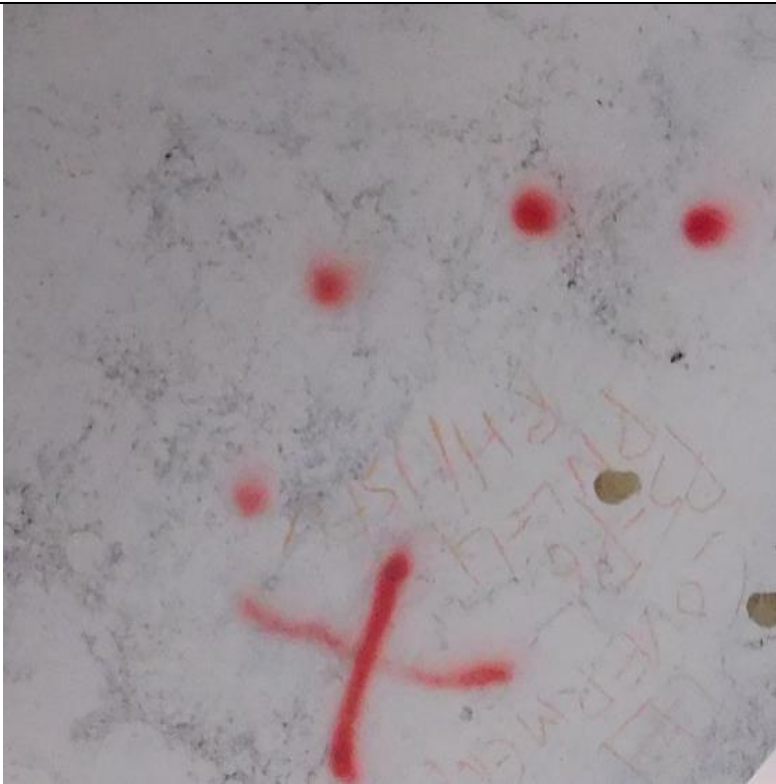
Photo 3

Location	P5-P6 PANEL-4	
	Nature of Distress	Minor & Major Cracks	
	Extent & Severity	Severe	
Photo 4

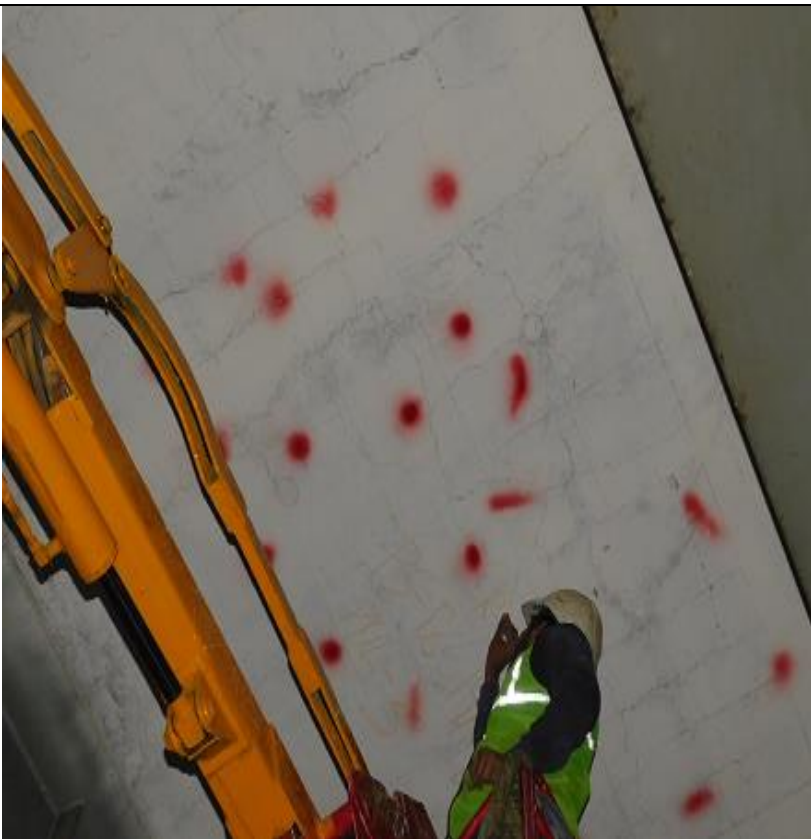
Location	P5-P6 PANEL-3	
	Nature of Distress	Minor & Major Cracks	
	Extent & Severity	Severe

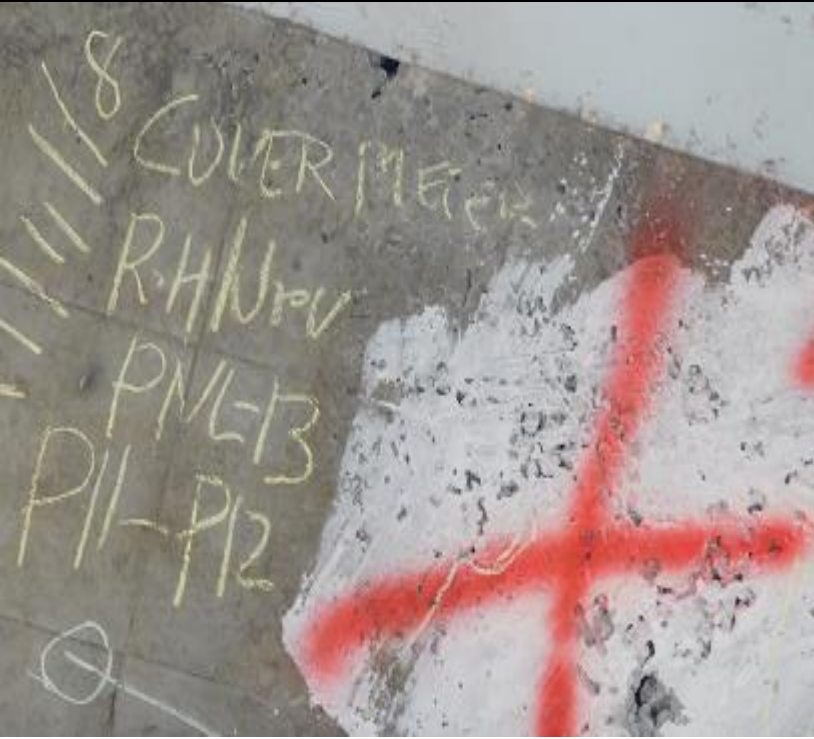
Photo 5

Location	P11-P12 PANEL-13	
	Nature of Distress	Spalling & Major Cracks	
	Extent & Severity	Severe	
Photo 6

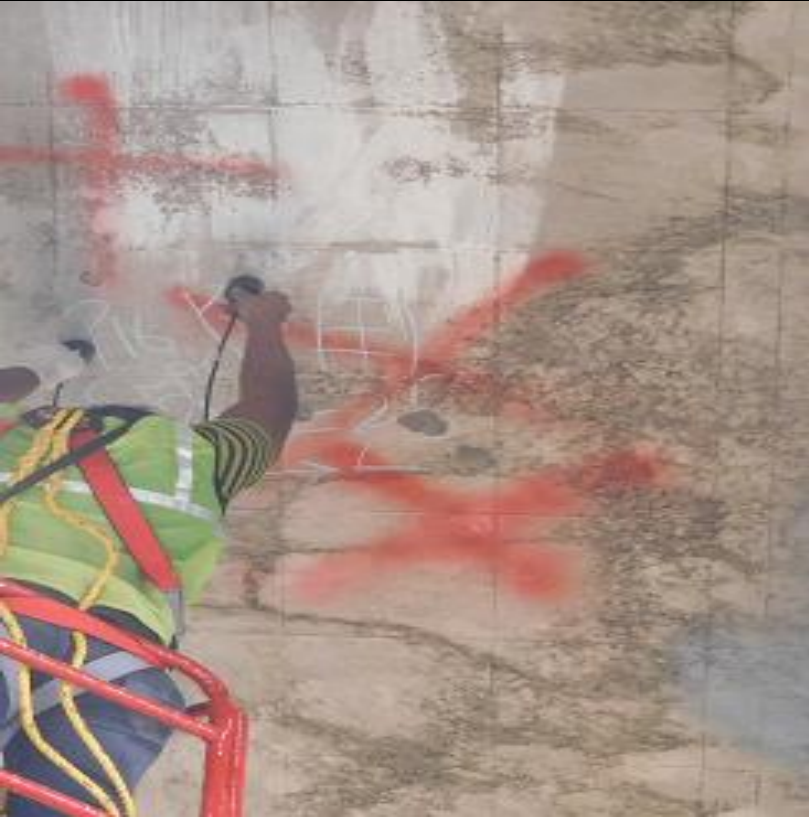
Location	P16-P17 PANEL-25	
	Nature of Distress	Minor Cracks & Spalling	
	Extent & Severity	Moderate

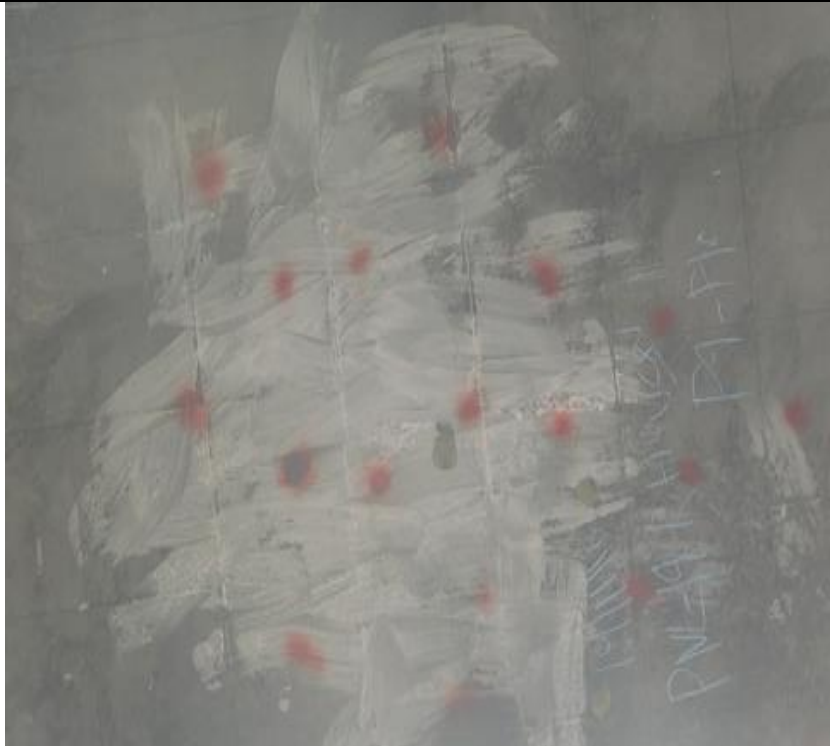
Photo 7

Location	P9-P10 PANEL-19
			Nature of Distress	Minor Cracks, Honeycombing spalling
			Extent & Severity	Moderate
Photo 8

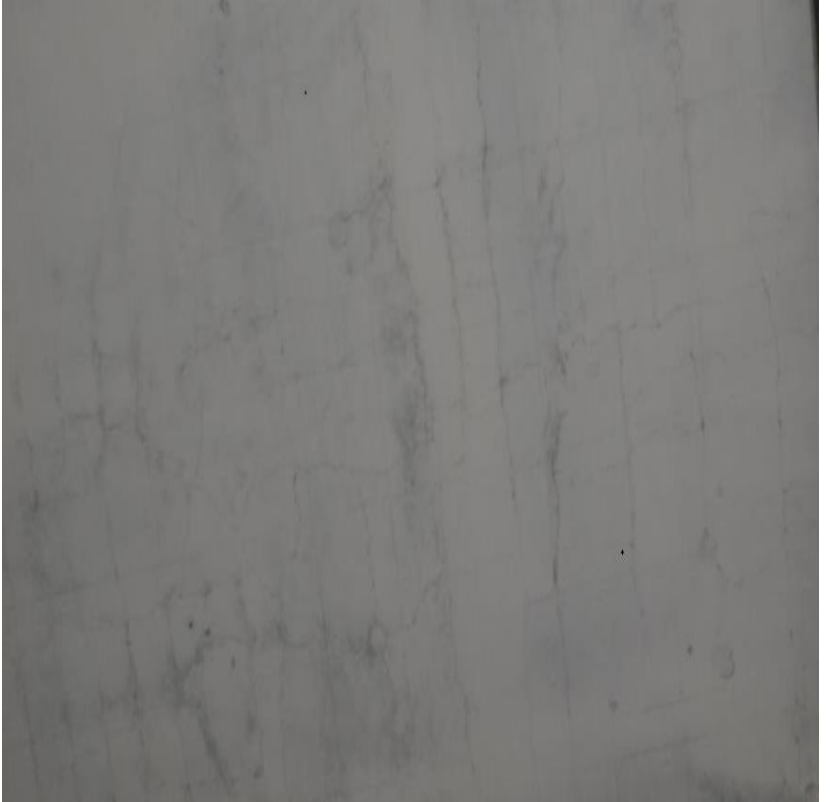
Location	P17-P18 PANEL-6
			Nature of Distress	Minor & Major Cracks
			Extent & Severity	Severe

There is Depression/ pot holes observed on damage panels like; P17-P18 (Panel-6) on road at Nand Nagri Flyover.

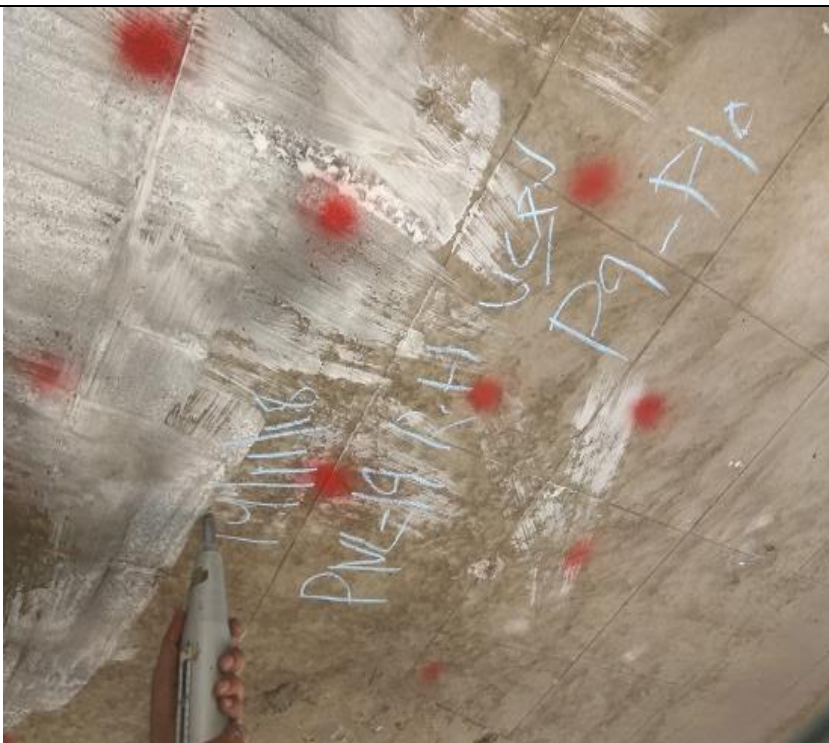
Photo 9		Location P9-P10 PANEL-19	Nature of Distress Minor Cracks & Honeycombing	Extent & Severity Moderate

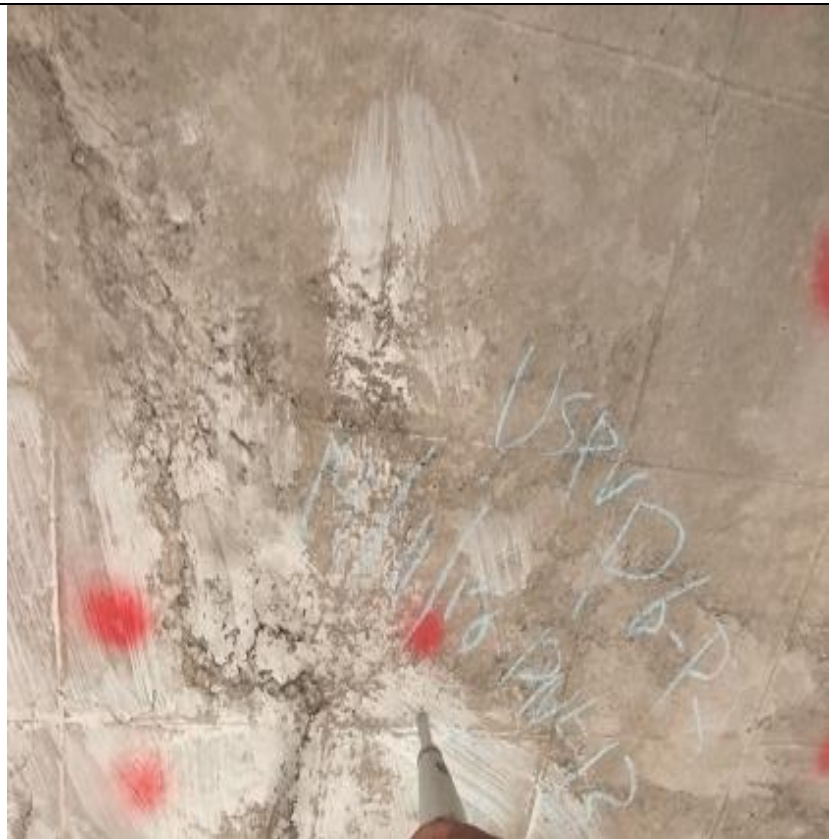
Photo 10		Location P6-P7 PANEL-13	Nature of Distress Major Cracks & Honeycombing	Extent & Severity Severe

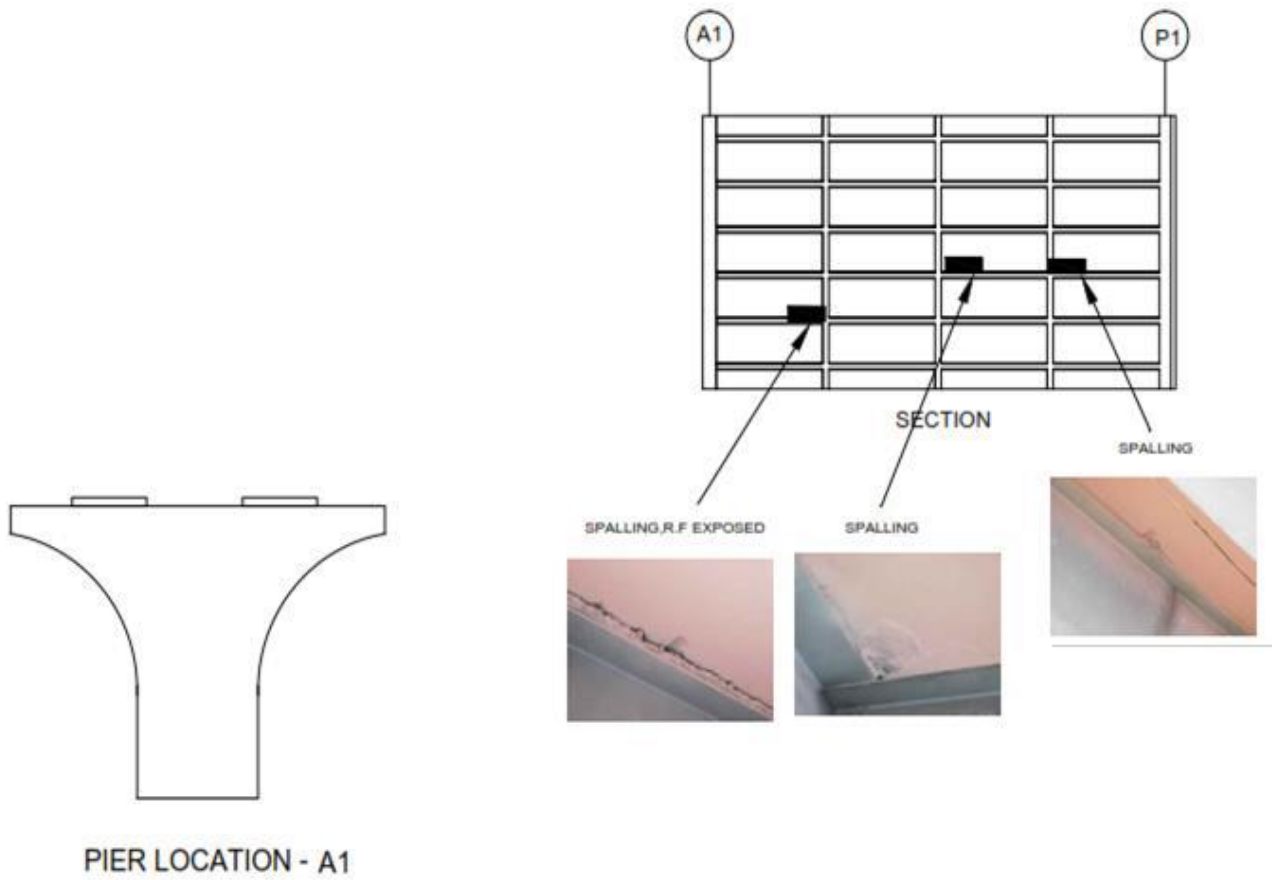
Fig. 2. Spalled concrete on the soffit of the panel maybe between A1-P1

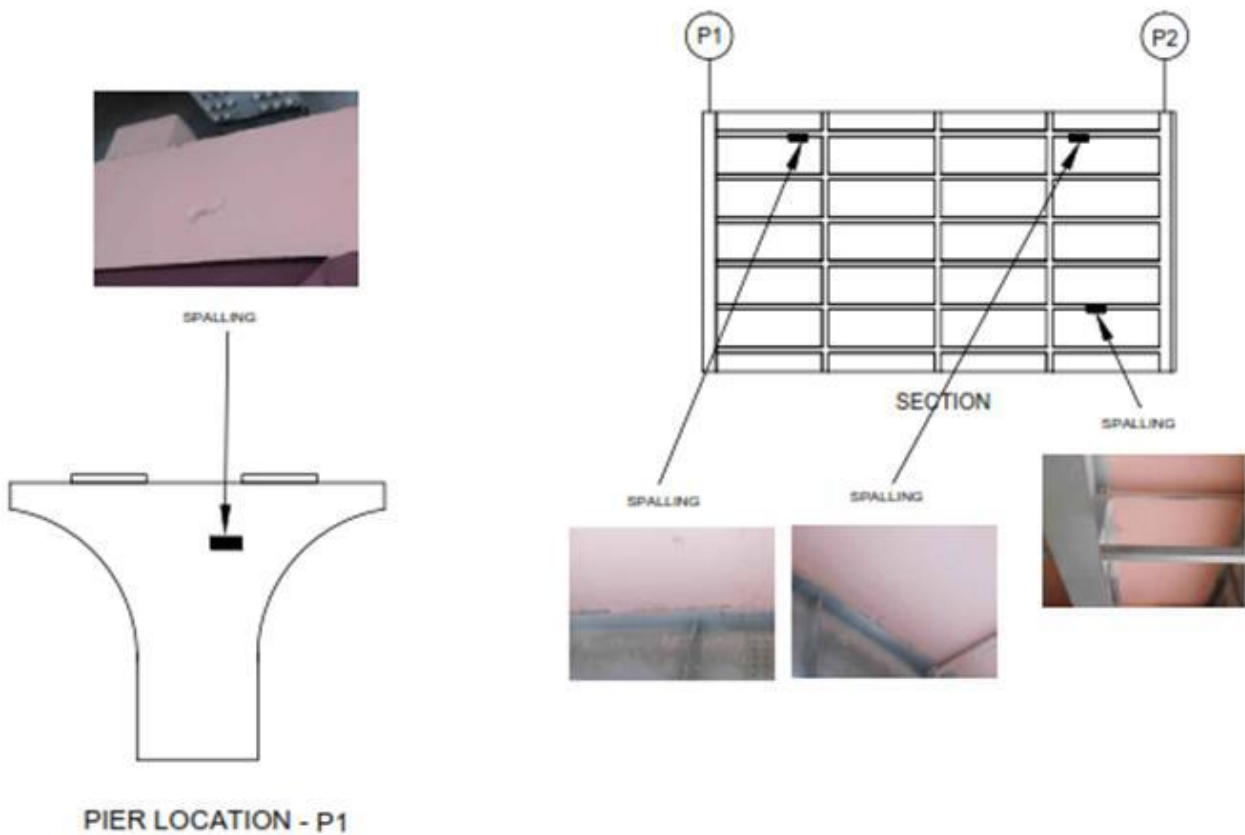
Fig. 3. Spalling of concrete near the junction of girder and panels between P1-P2

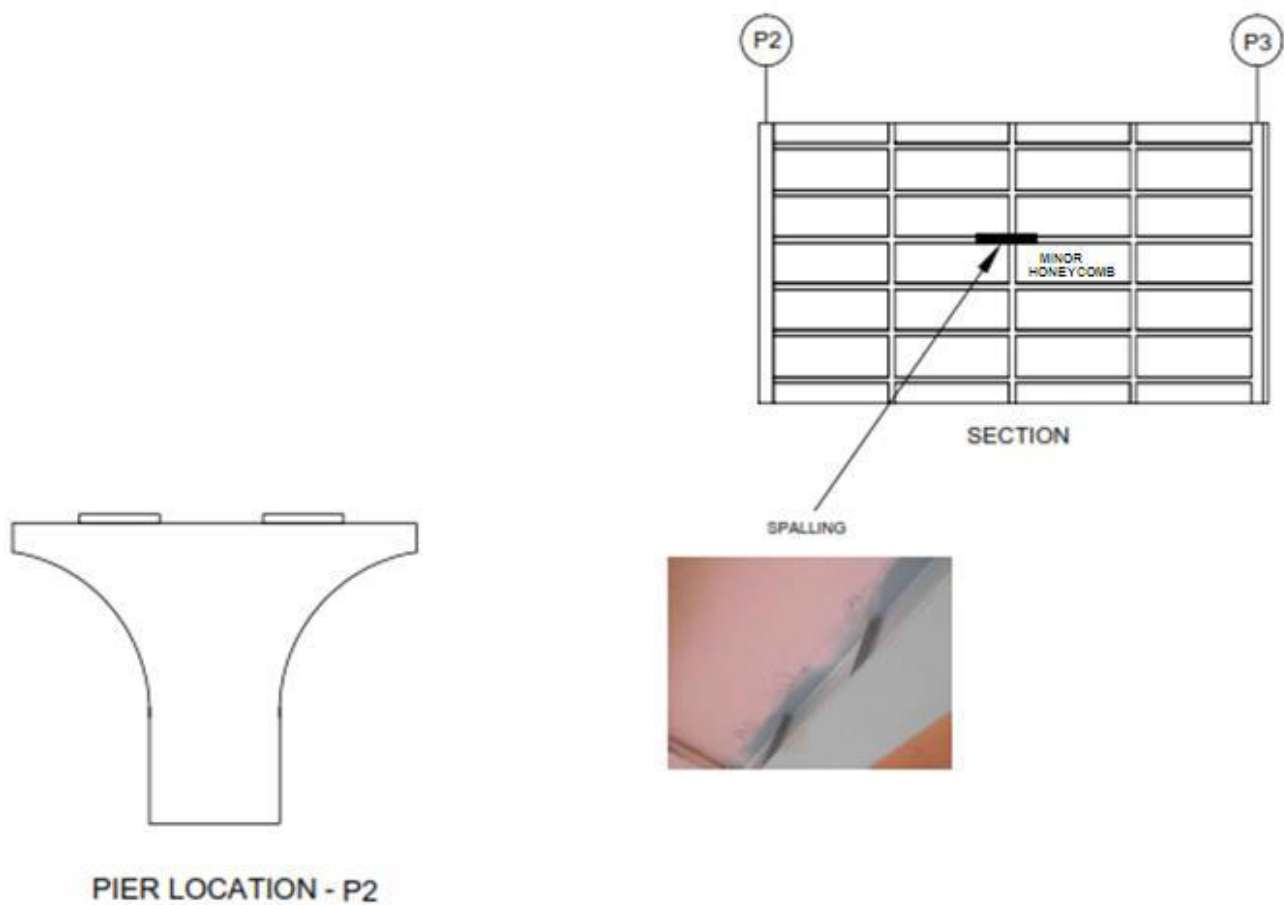
Fig. 4.Minor honeycomb formed on the soffit of the panels between P2-P3

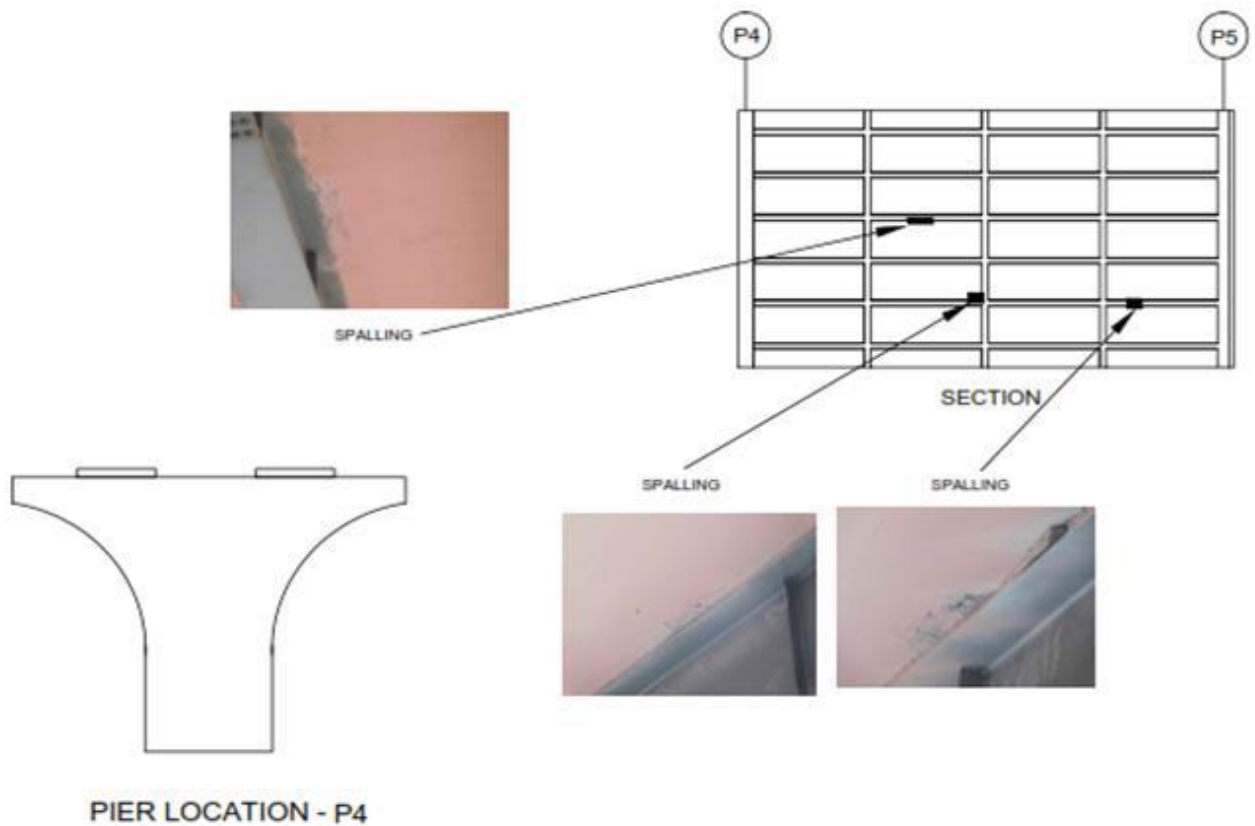
Fig. 5. Spalling of concrete near the junction of girder and panels between P4-P5

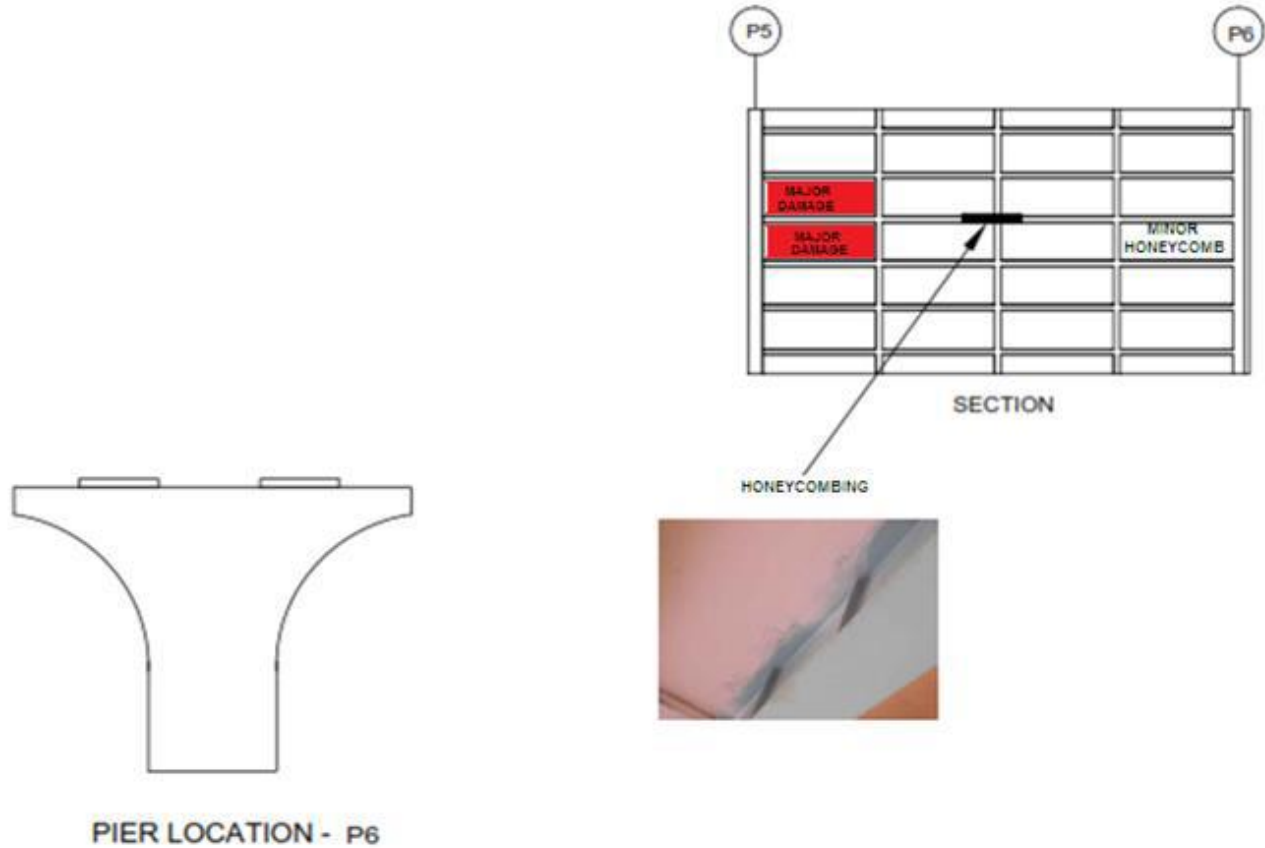
Fig. 6.Major damaged panels

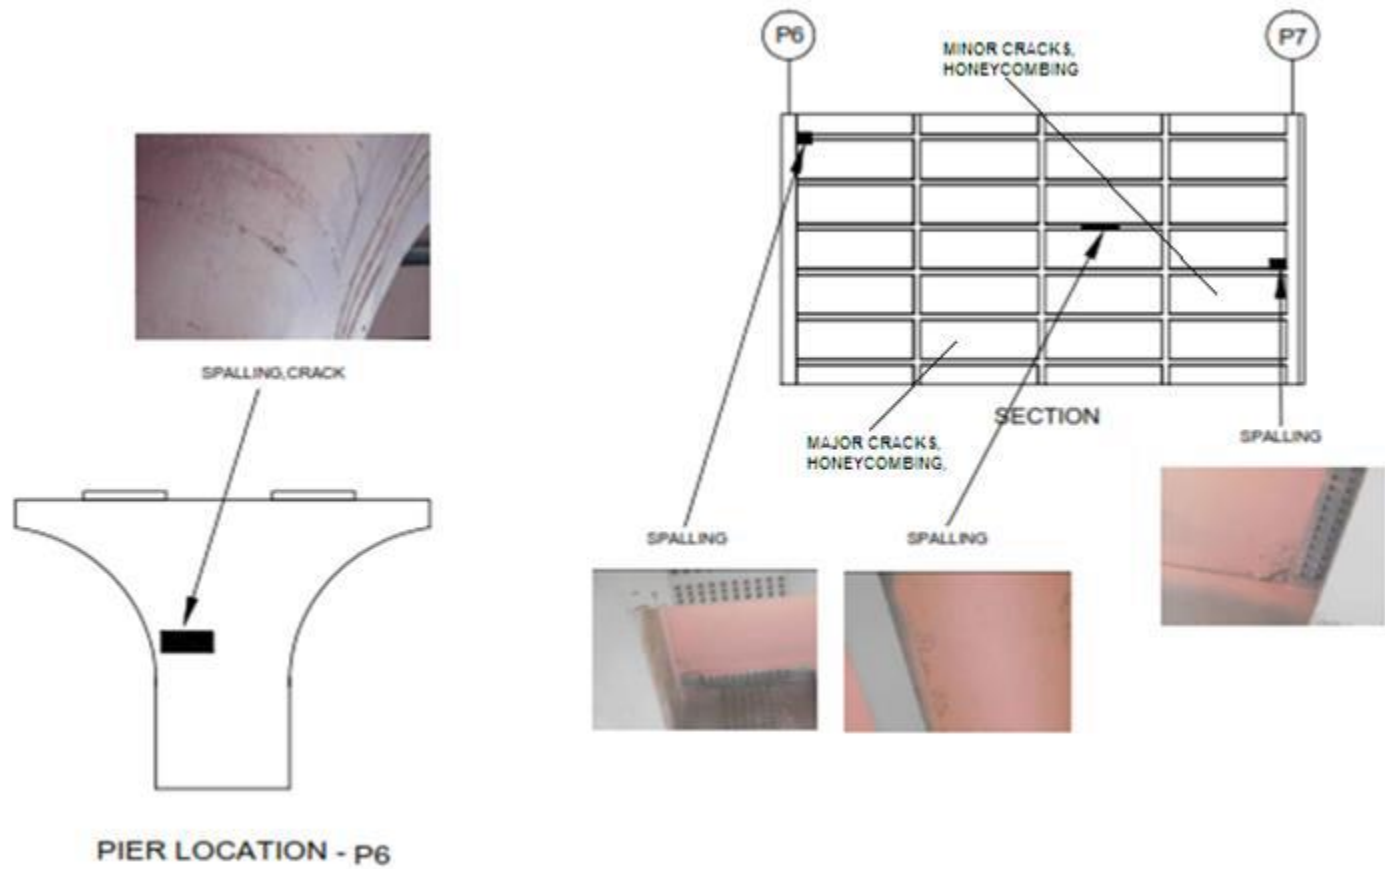
Fig. 7. Spalling of concrete near the junction of girder and panels between P6-P7

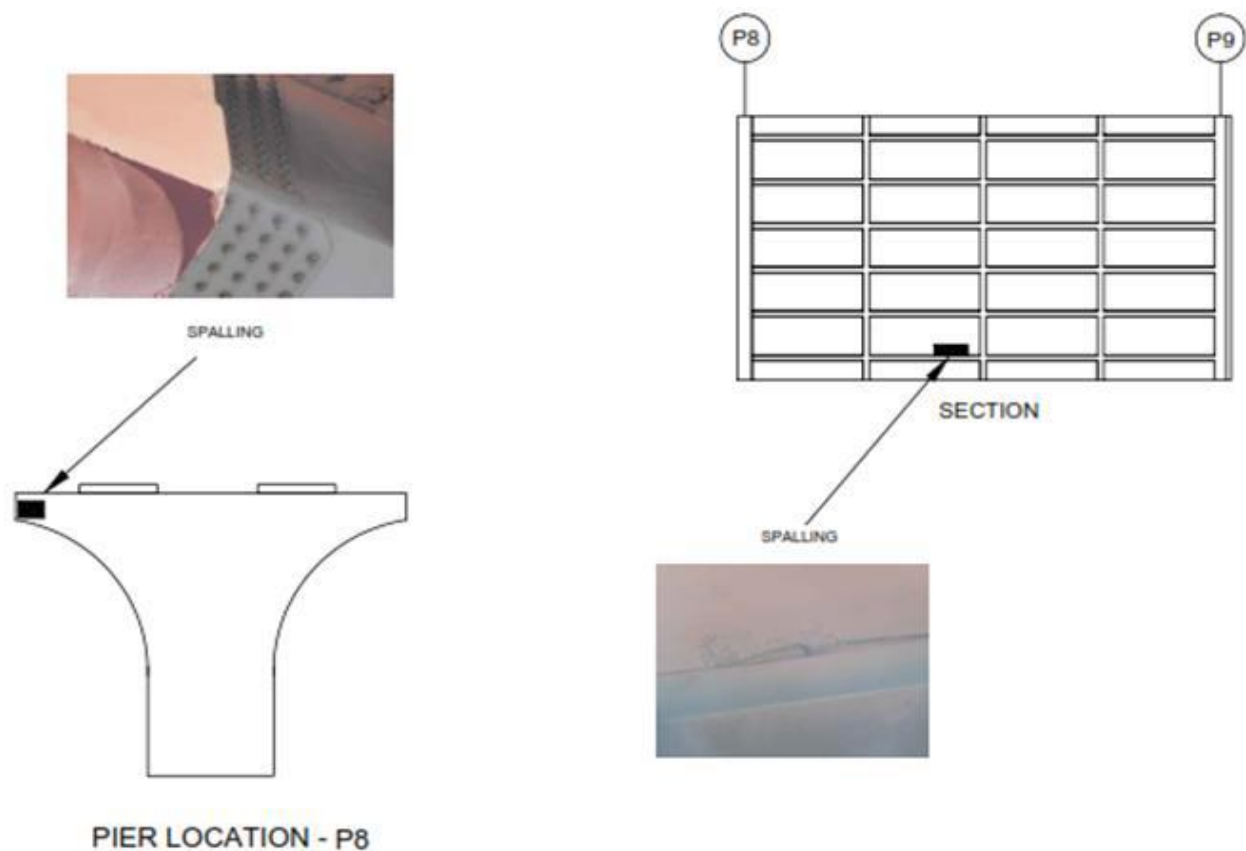
Fig. 8.Spalling piercap and junction of panel with steel girder in P8-P9

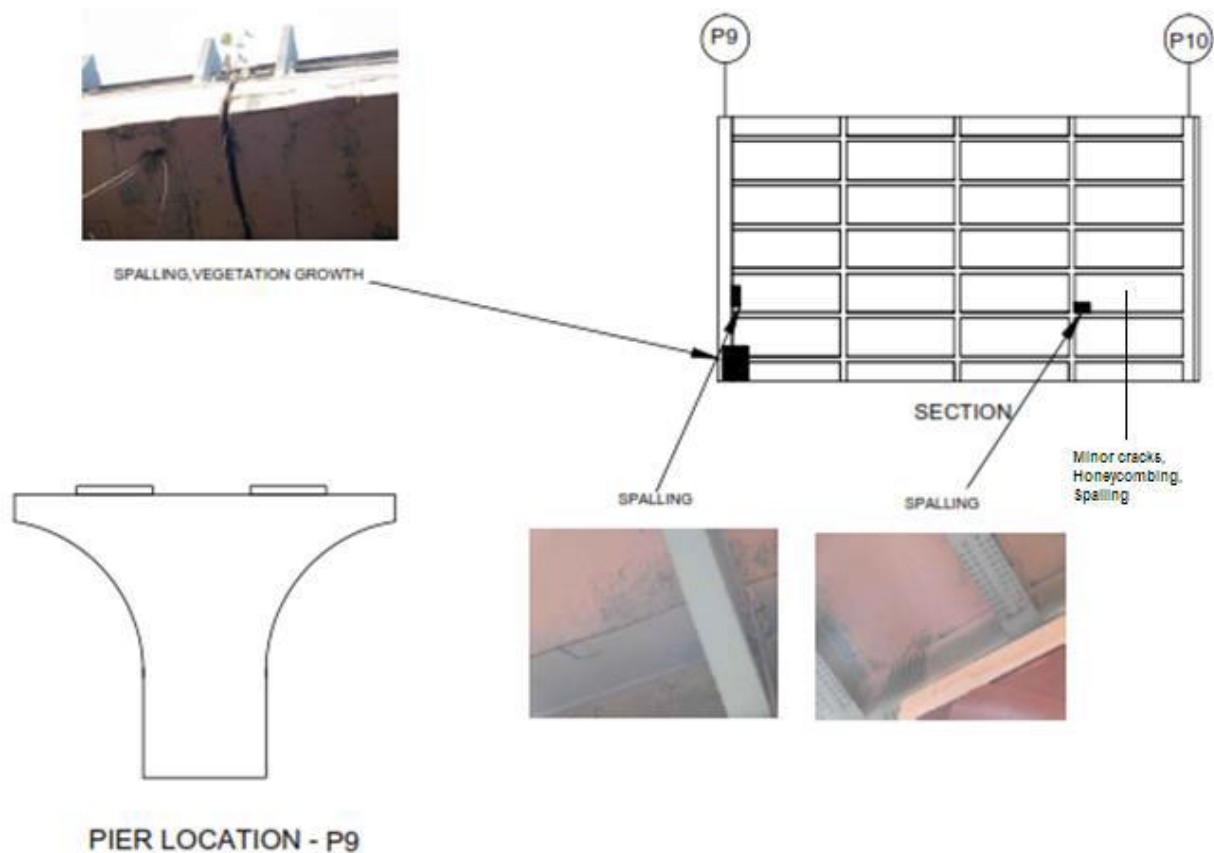
Fig. 9.Spalling and Vegetation growth seen in between P9-P10

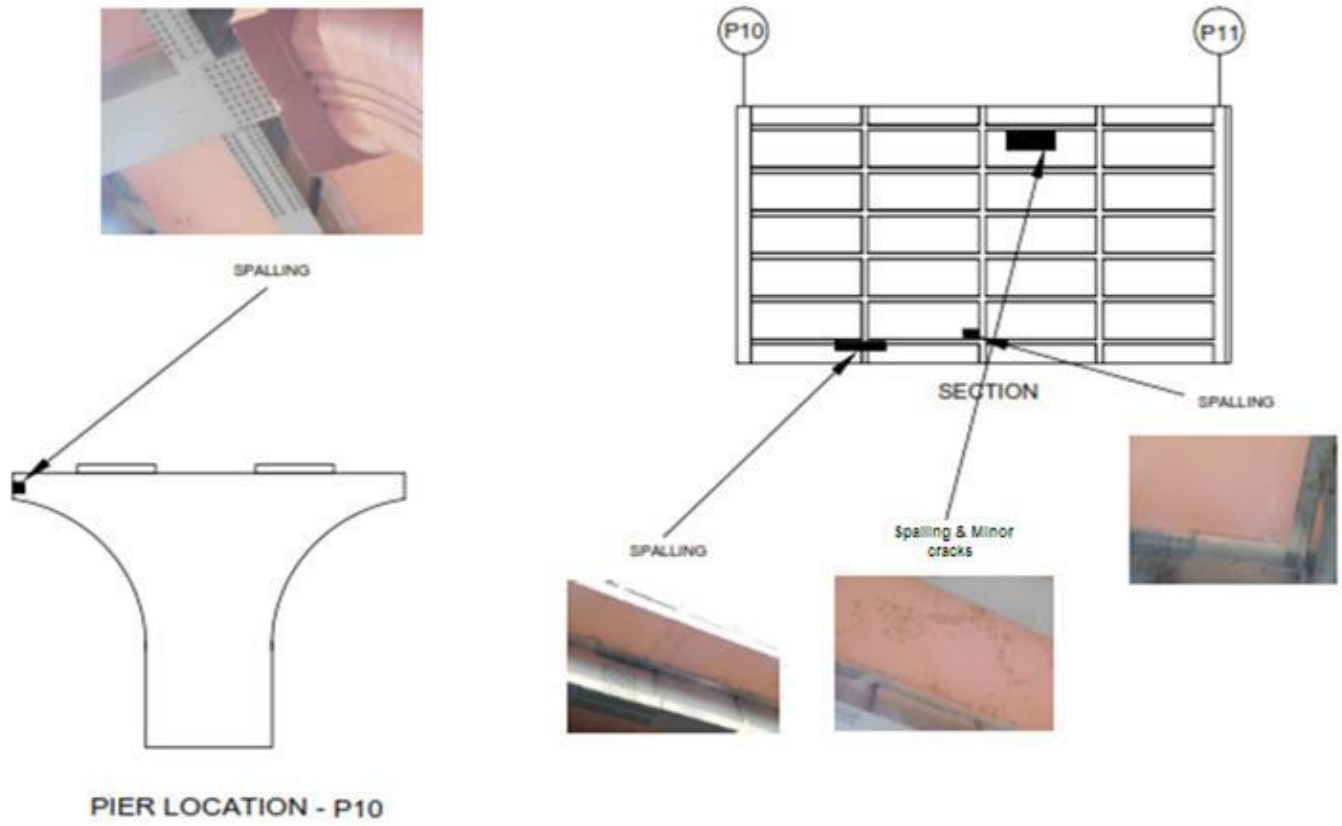
Fig. 10.minor cracks seen in between P10-P11

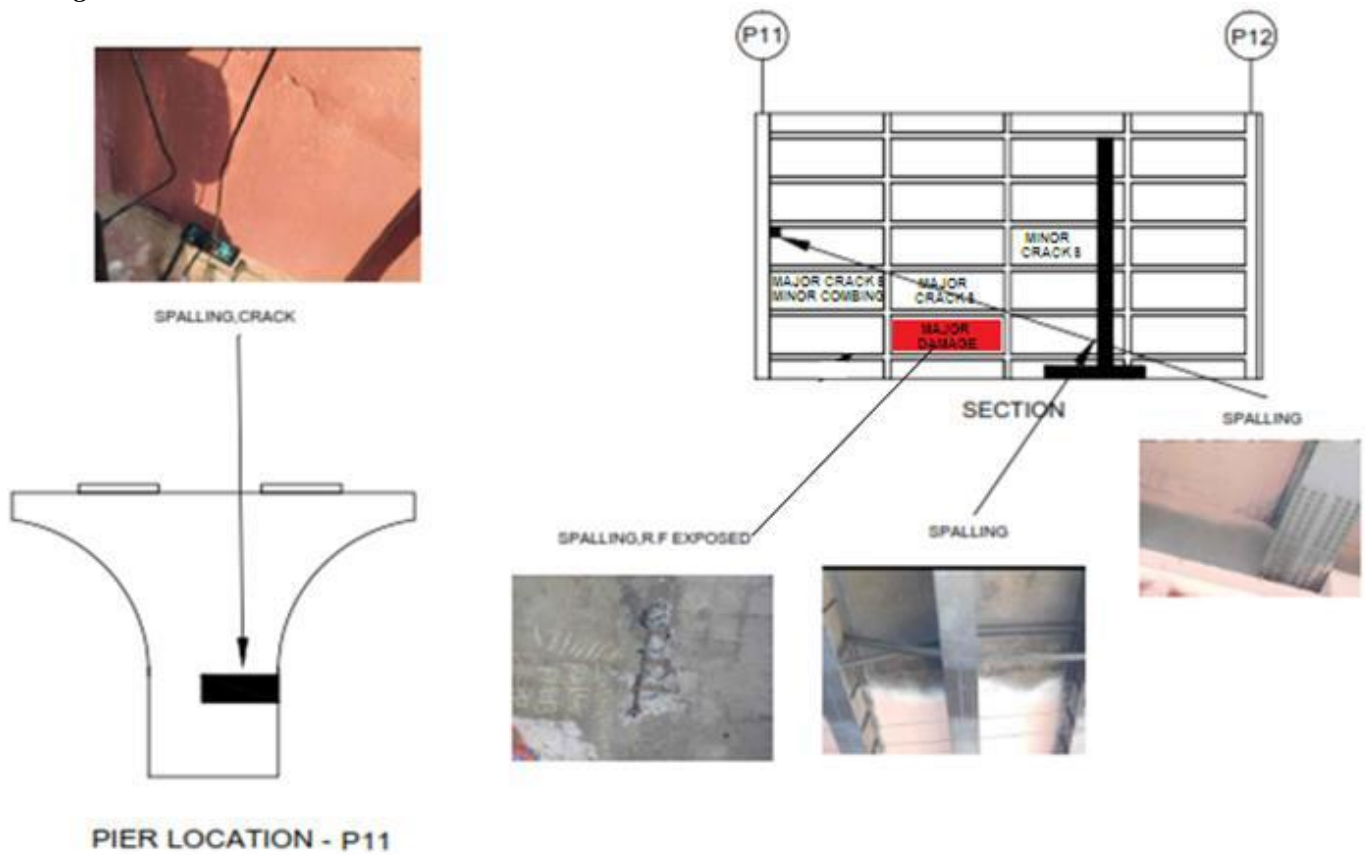
Fig. 11.Major damaged panel in between P11-P12

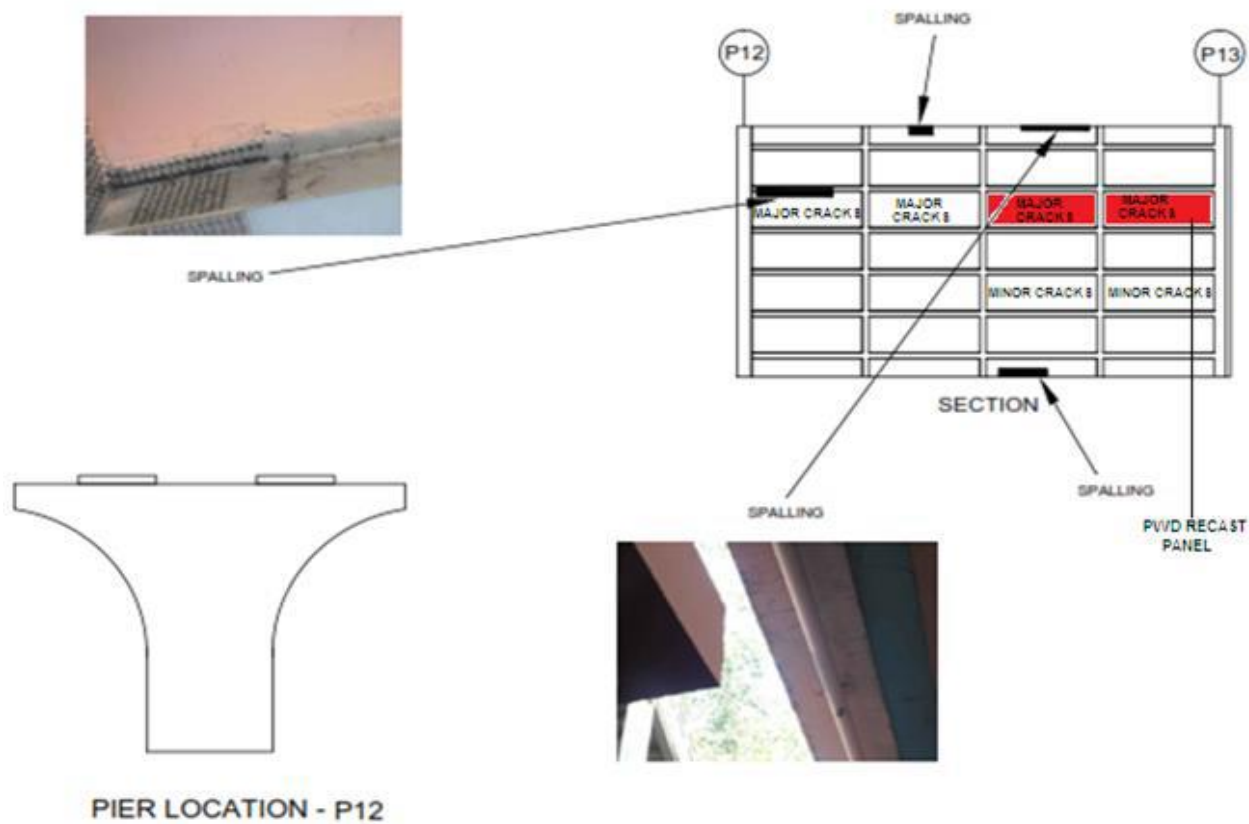
Fig. 12. Major damaged panel with minor cracks in between P12-P13

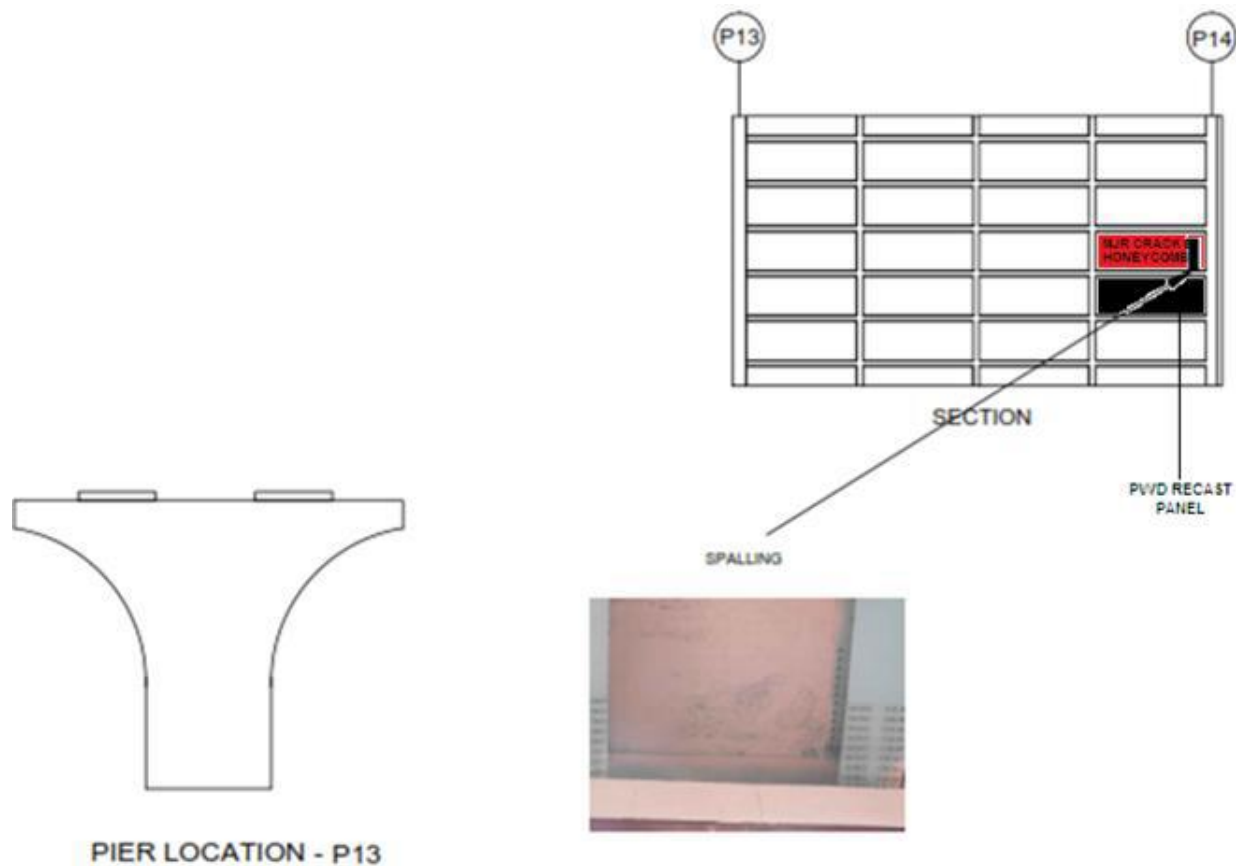
Fig. 13. Major distress panel in between P13-P14

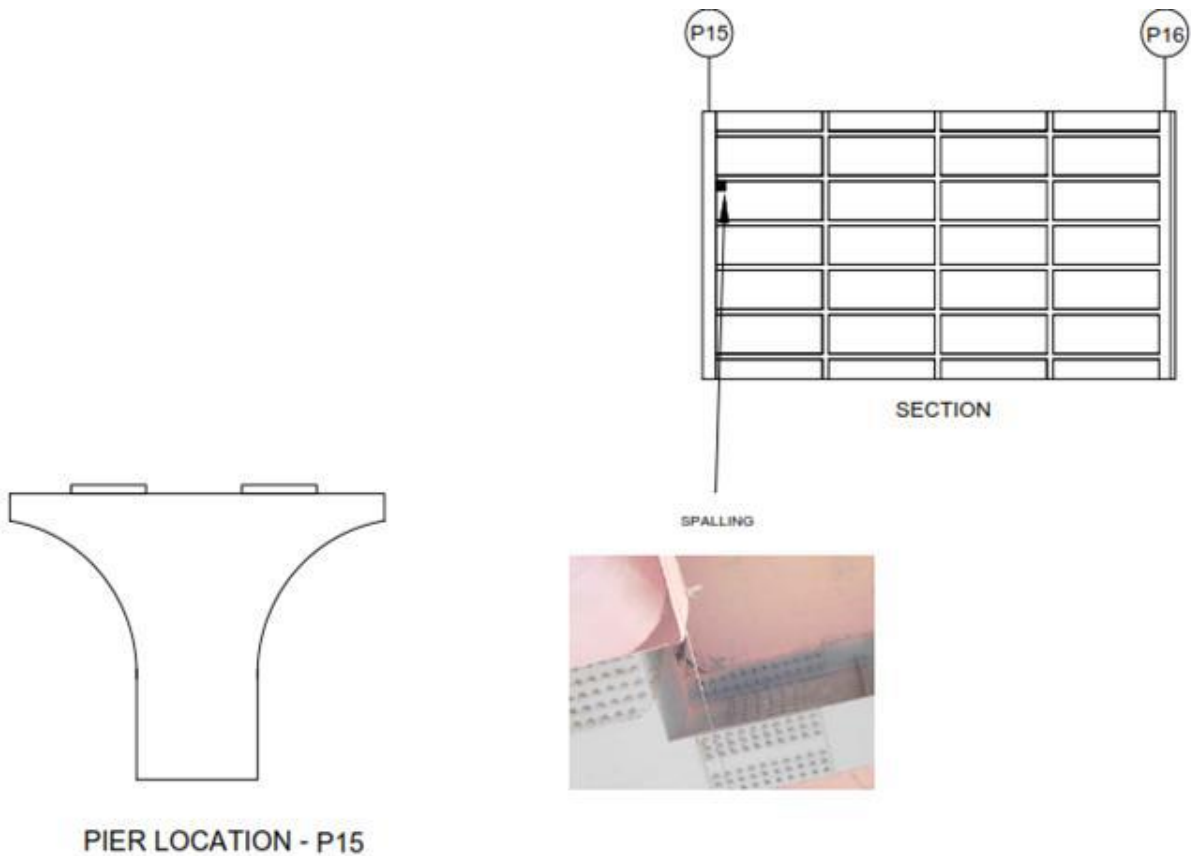
Fig. 14. No major damage in between P15-P16

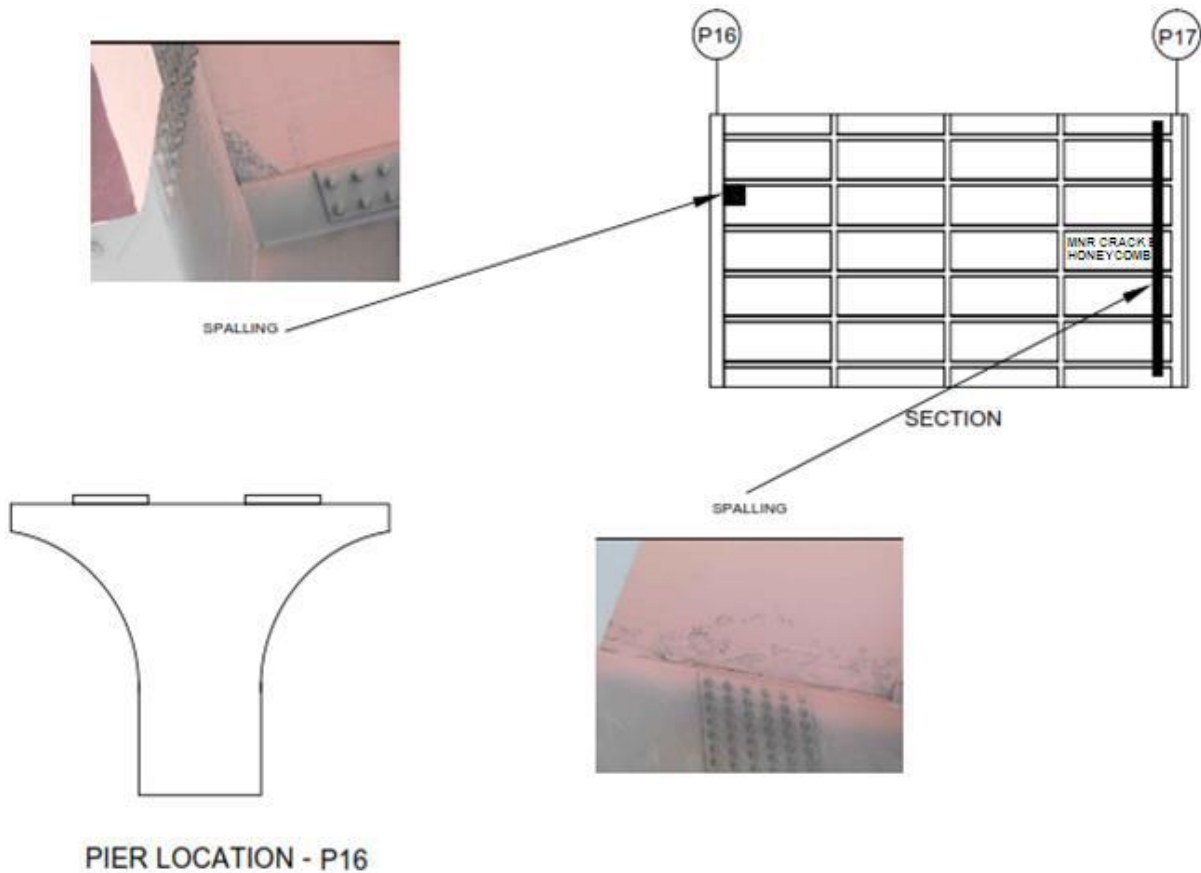
Fig. 15. Minor cracks with spalling noted in between P16-P17

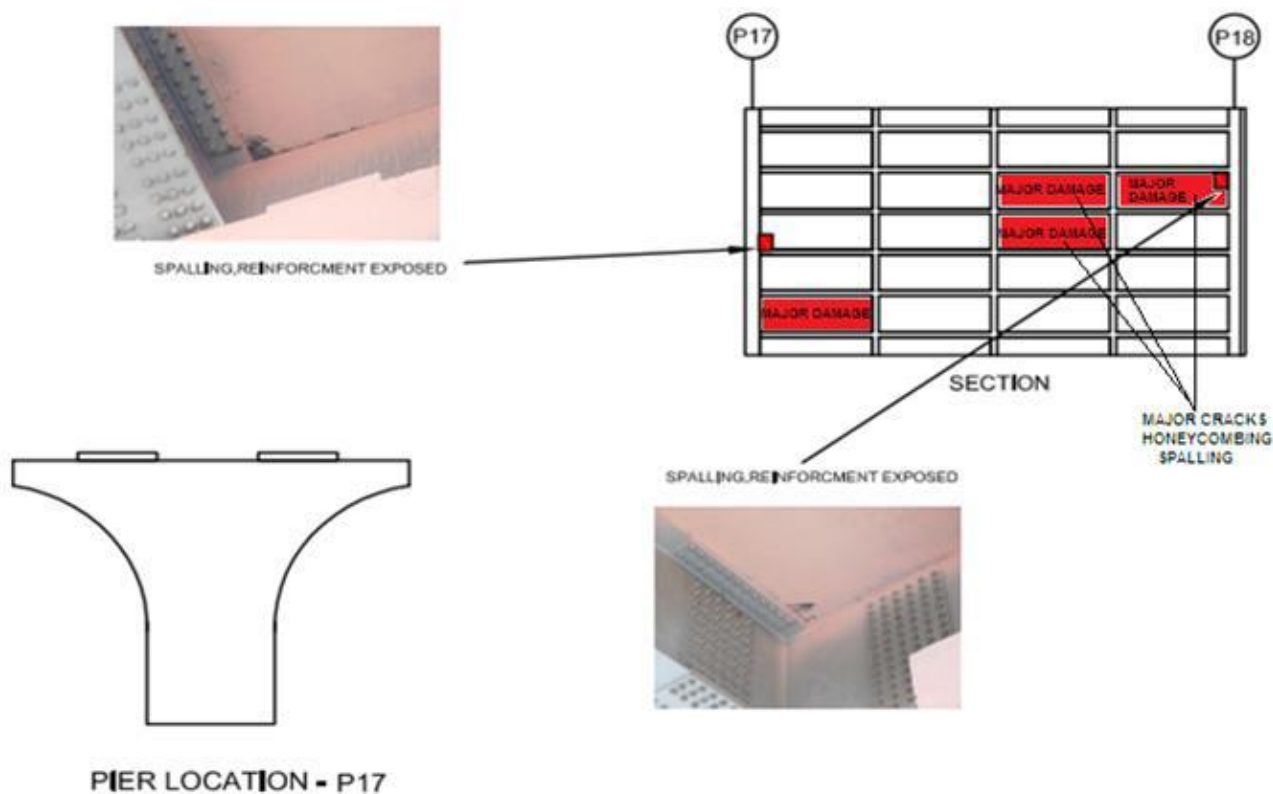
Fig. 16. Major distress seen in 4 panels in between P17-P18
