REPAIR & REHABILITATION OF ROB NANDNAGRI FLYOVER (at Road No. 68), DELHI

CONDITION STATUS REPORT AND REMEDIAL MEASURES ON NANDNAGRI FLYOVER (AT ROAD No.68) - DELHI

CONSTRUMA CONSULTANCY PVT. LTD.

FEBRUARY, 2019

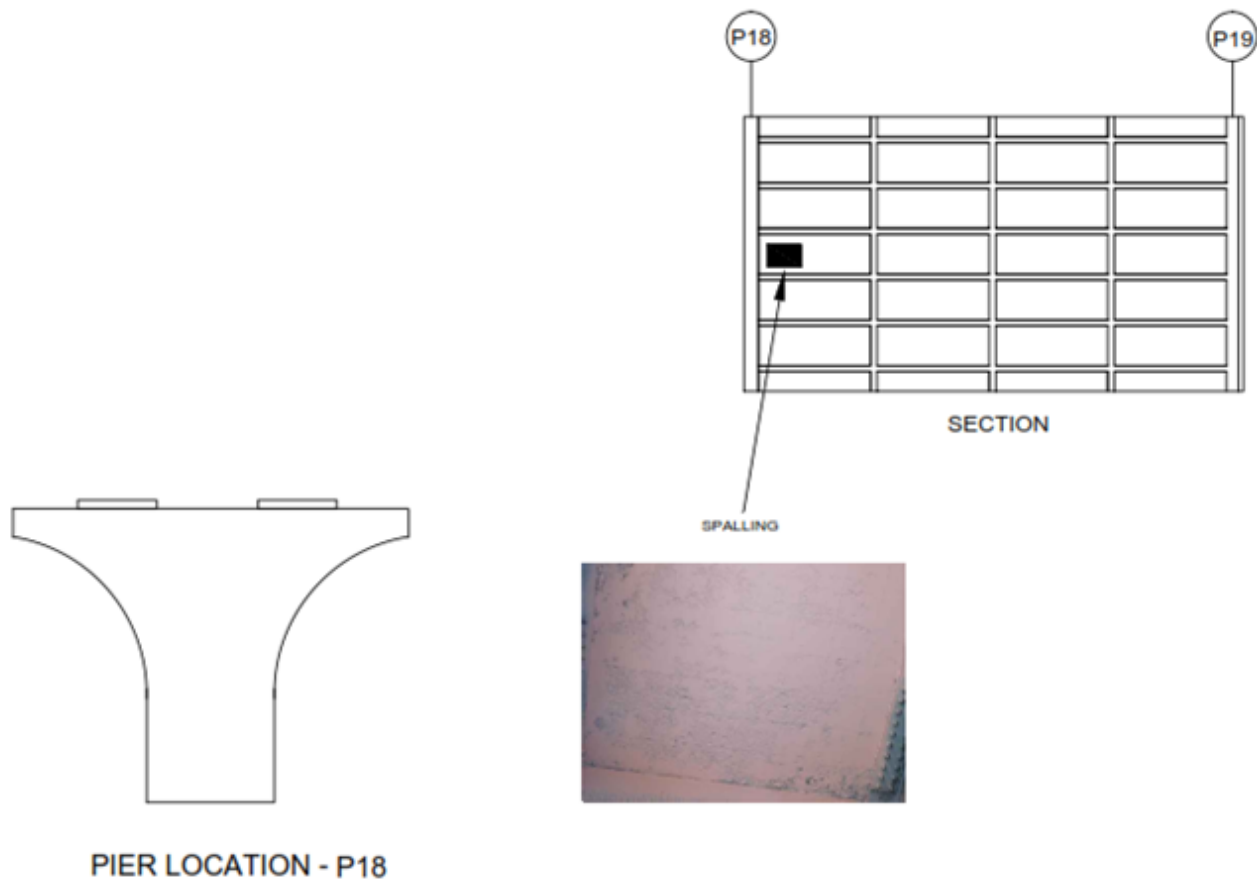
Fig. 17. Spalling noticed in one panel in between P18-P19

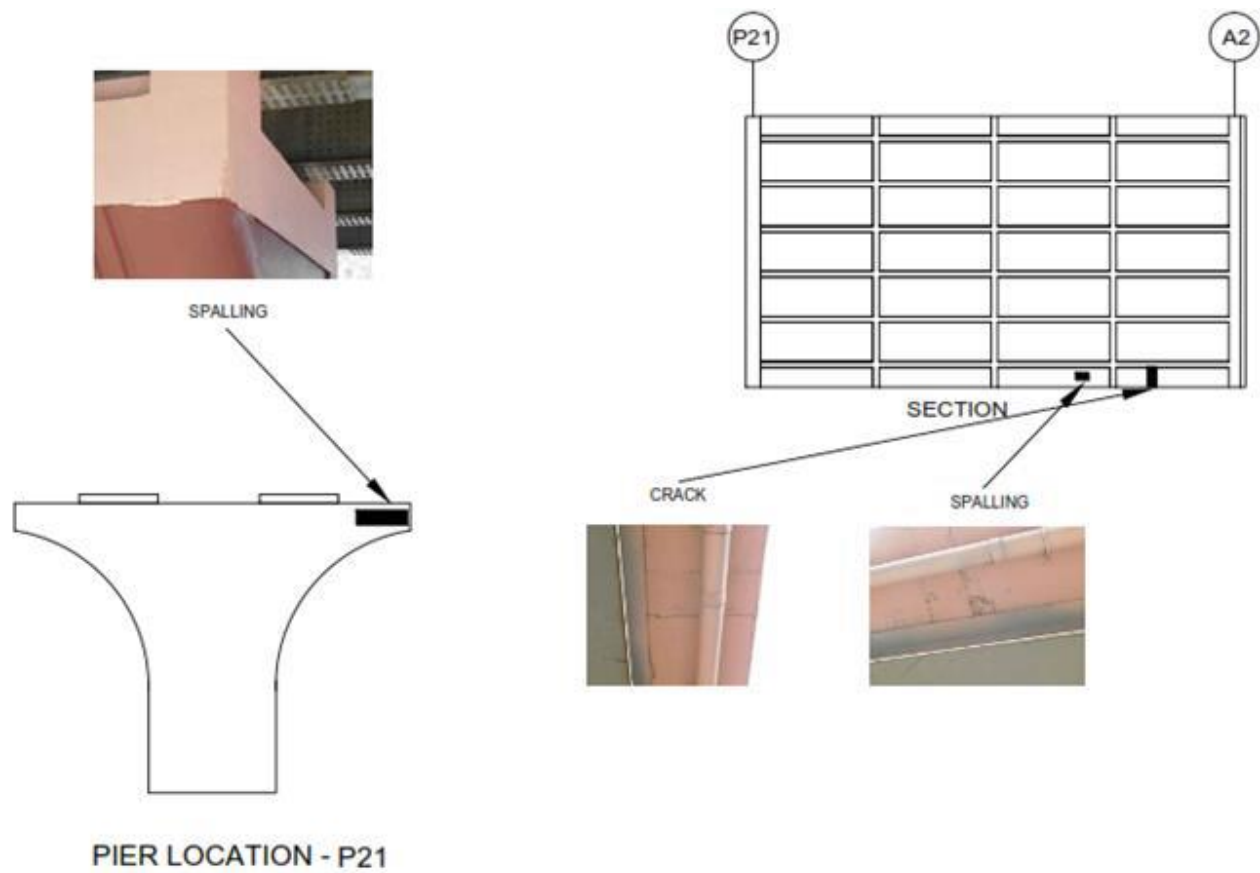
Fig.18. Minor cracks noticed in between P21-A2

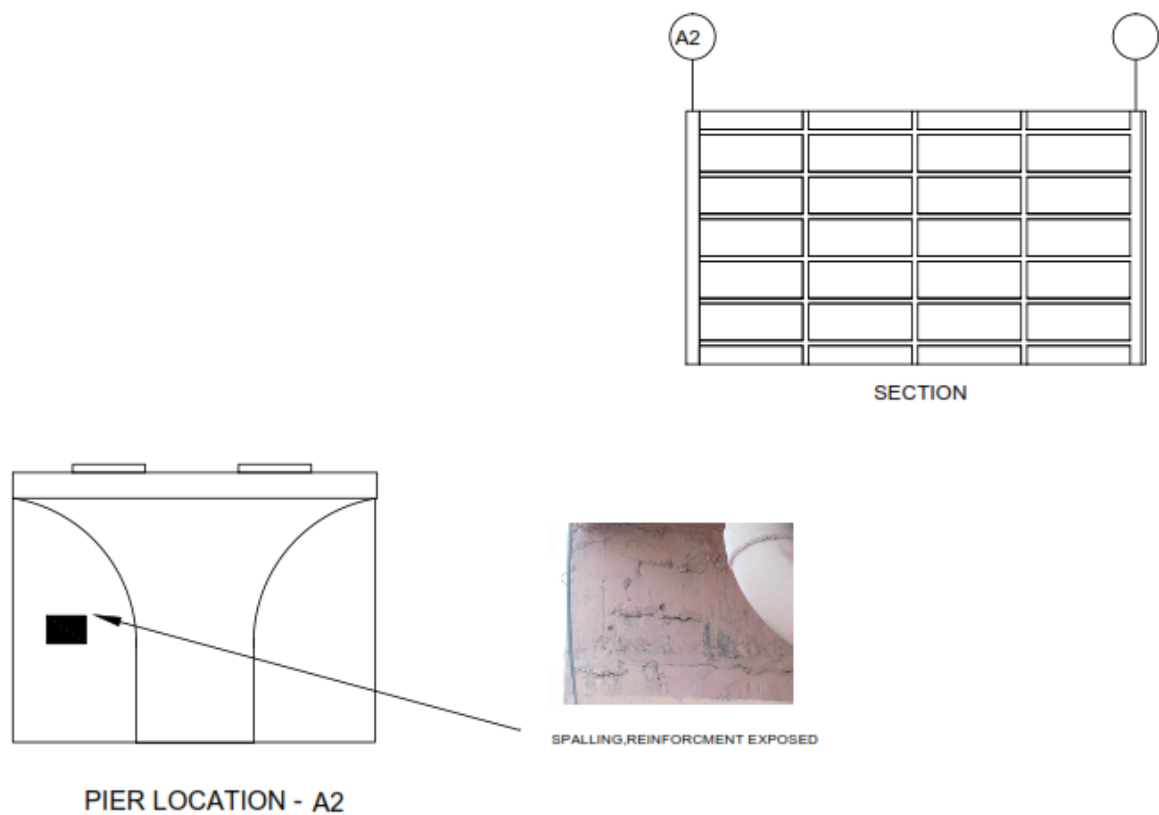
Fig. 19. Spalled concrete on the abutment A2

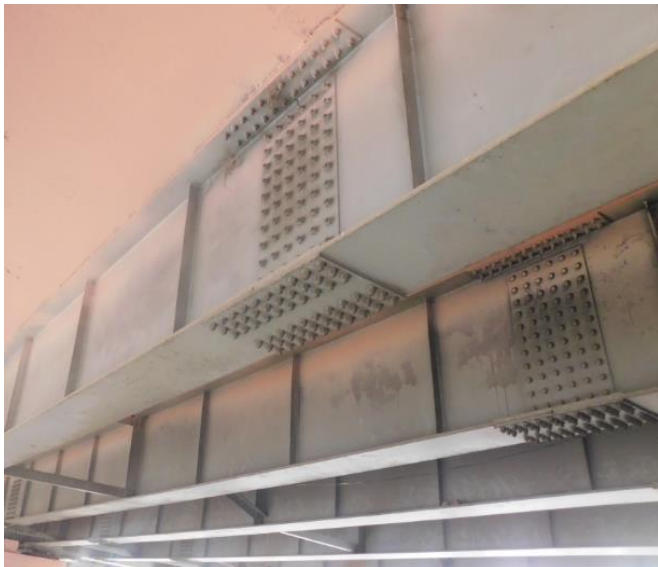
Photo 22. Steel girders showing no sign of corrosion

No paint peeling off, **No** paint bubbled and **No** corrosion noticed on web, flange and bracings with diaphragms in steel superstructure
HSFG bolts are in tight and showing no sign of corrosion are observed.

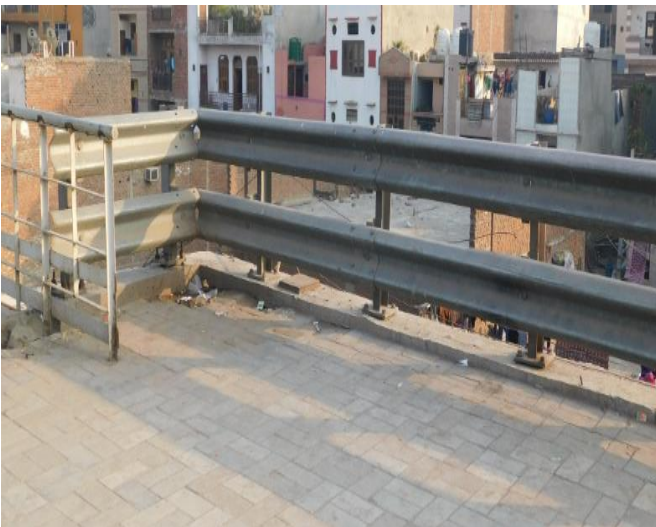
Photo 25. Roadside Grills in good condition.

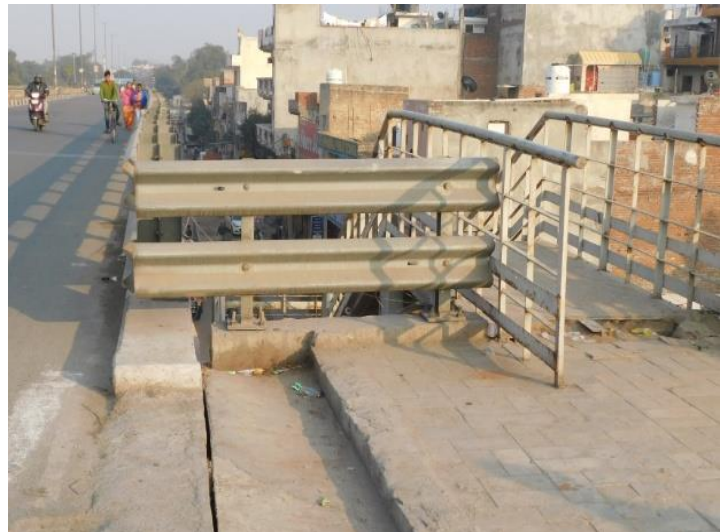
Photo 26. Crash Barrier are in good condition without any damages

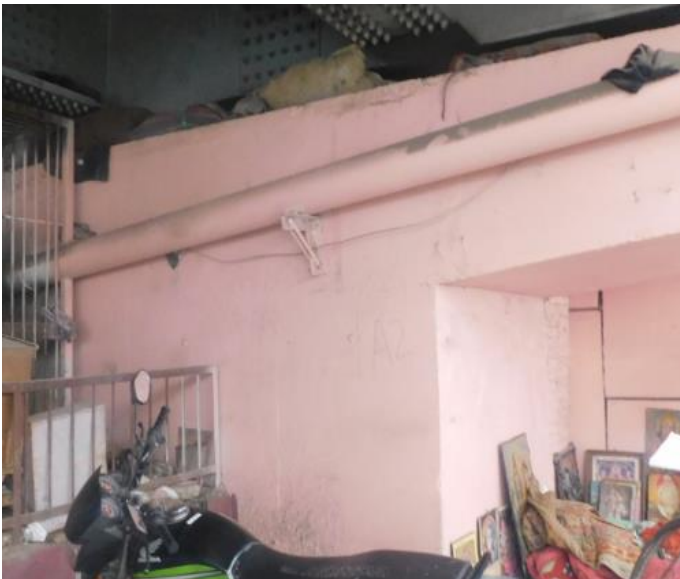
Photo 31. Abutments noted with no distress

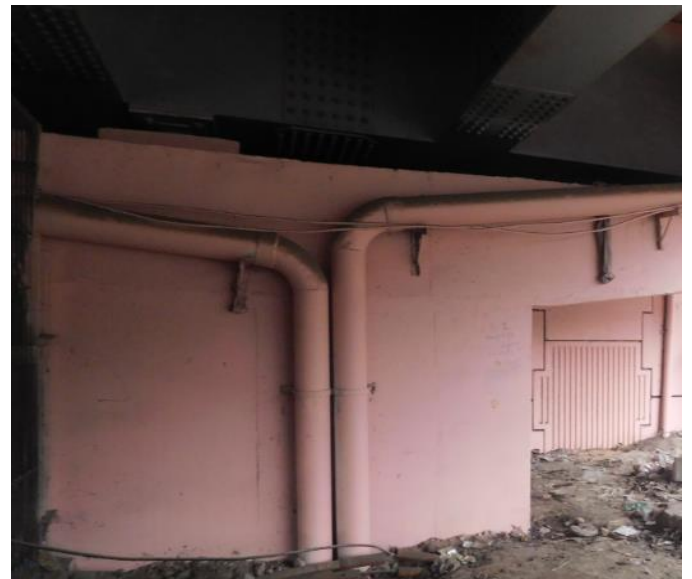
Photo 31.a) Abutments noted with no distress

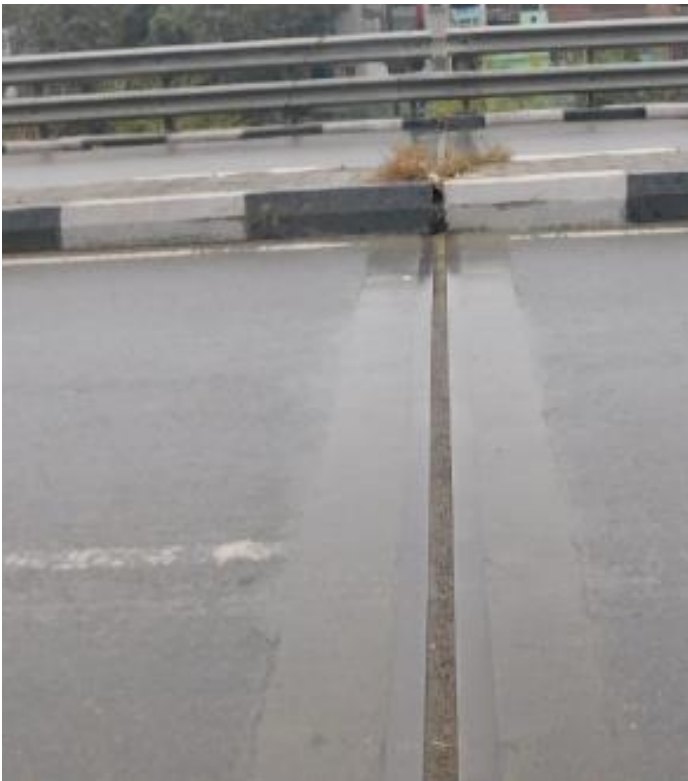
Photo 33. No damages in expansion joints

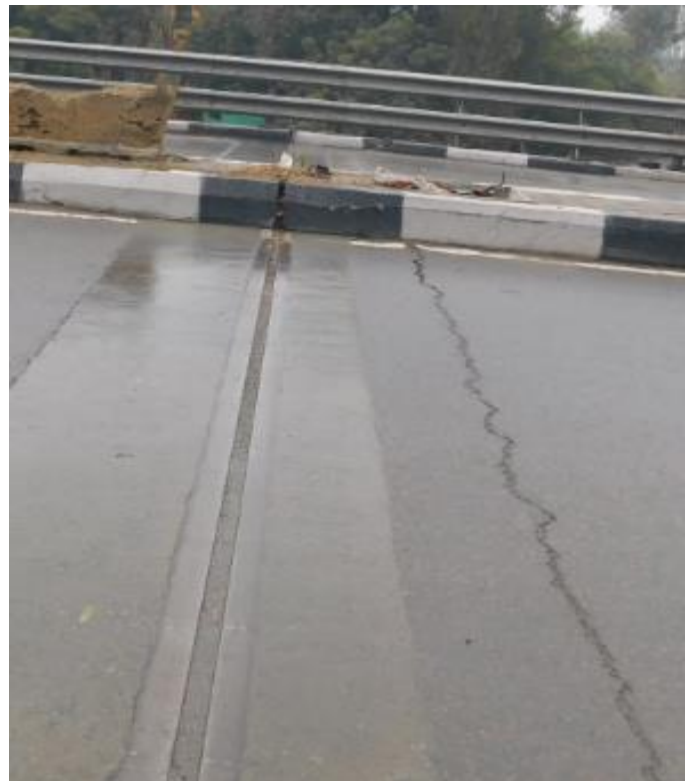
Photo 34. Transverse crack due to tension near Expansion joints

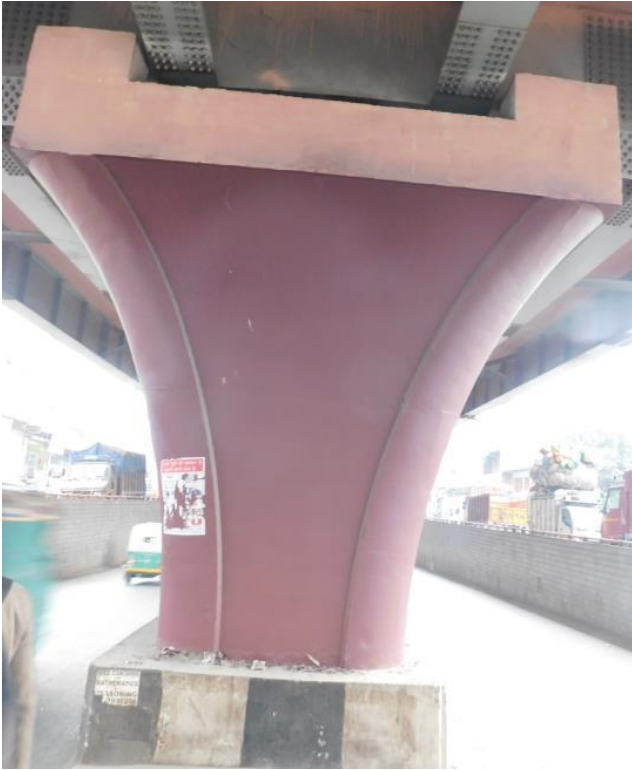
Photo 35. Piers showing no distress or damages

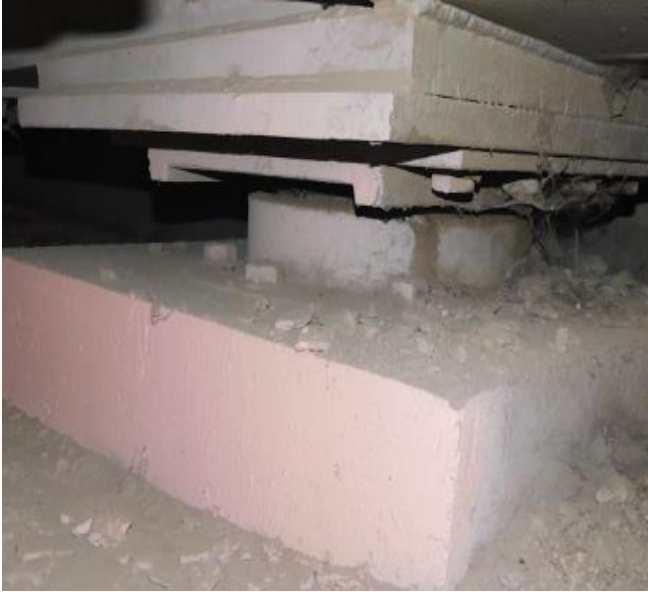
Photo 39. Bearings without any damages

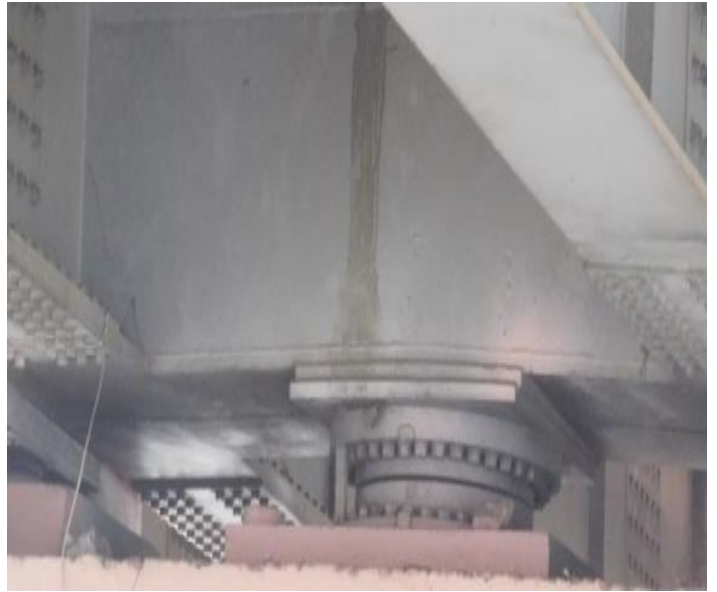
Photo 40. Bearings are in good condition

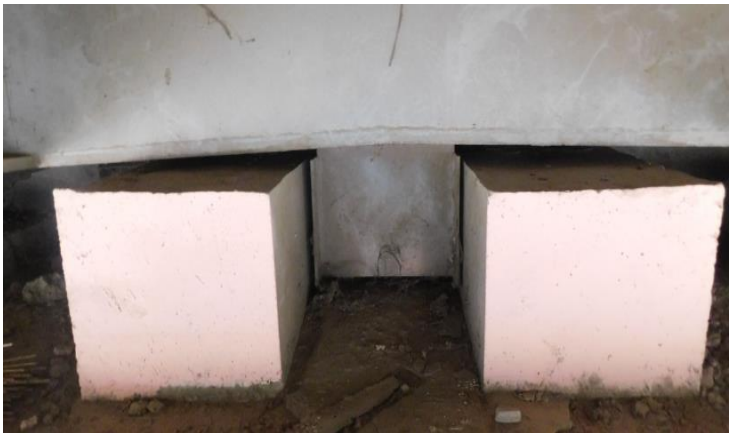
Photo 42. Seismic Restrainers showing no distress or damage

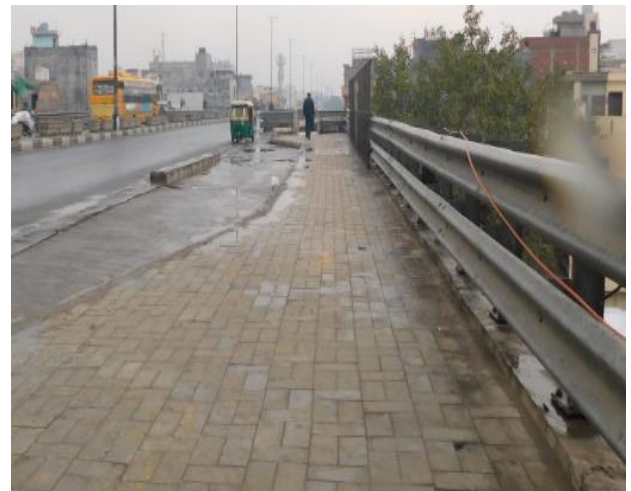
Photo 46. Footpath are in good condition

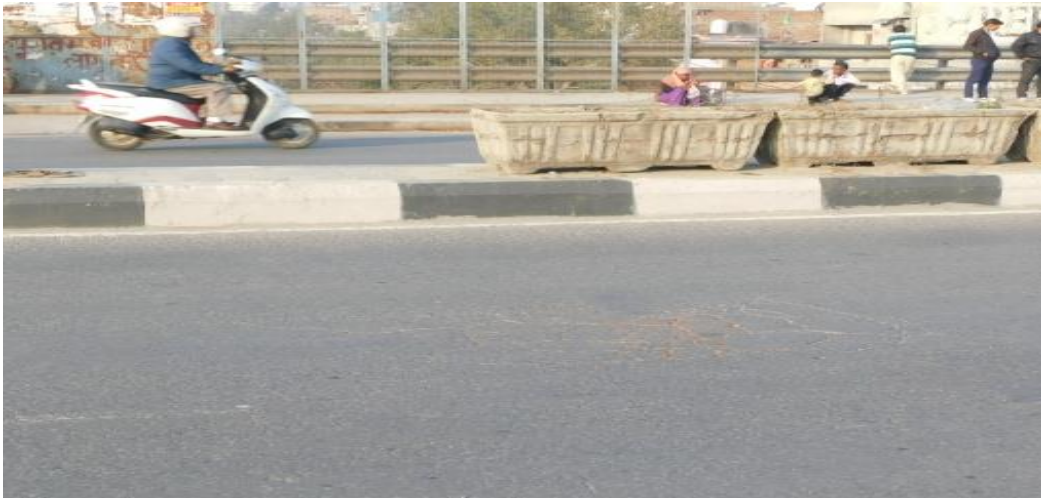
Photo 48. Depression / cracking in the bituminous layer

There is Depression/ pot holes observed on damage panels like; P17-P18 (Panel-6) on road at Nand Nagri Flyover.

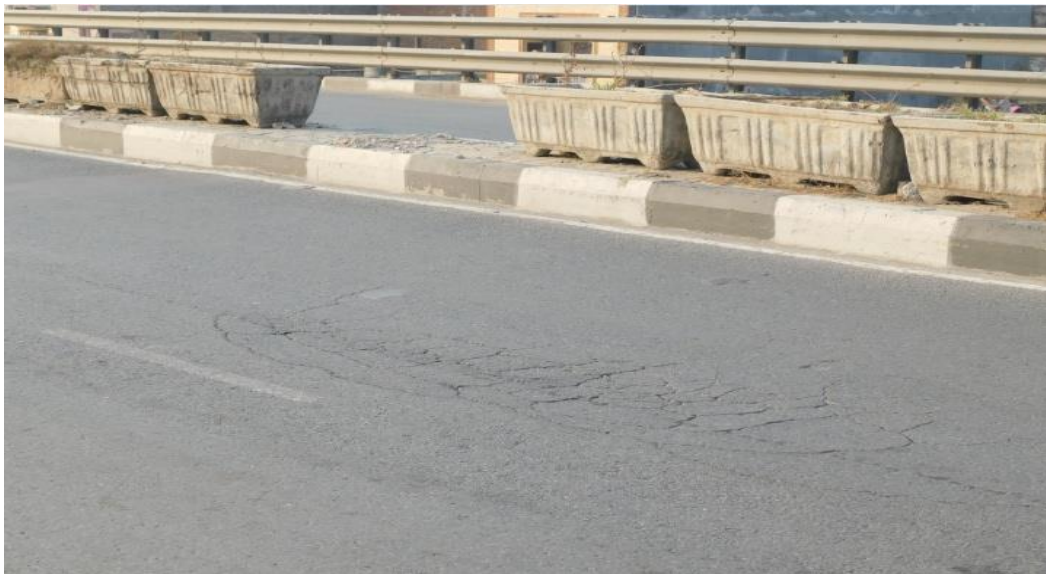
Photo 49. Distressed pattern on wearing coat

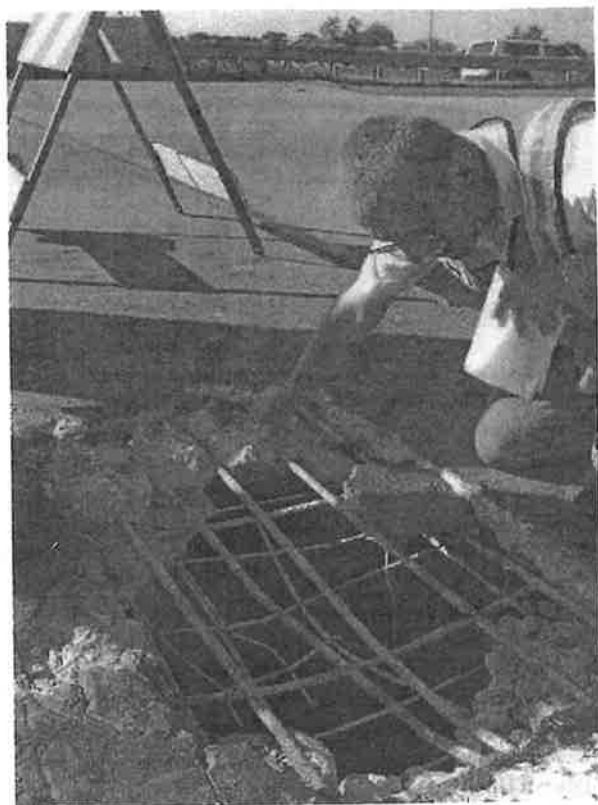
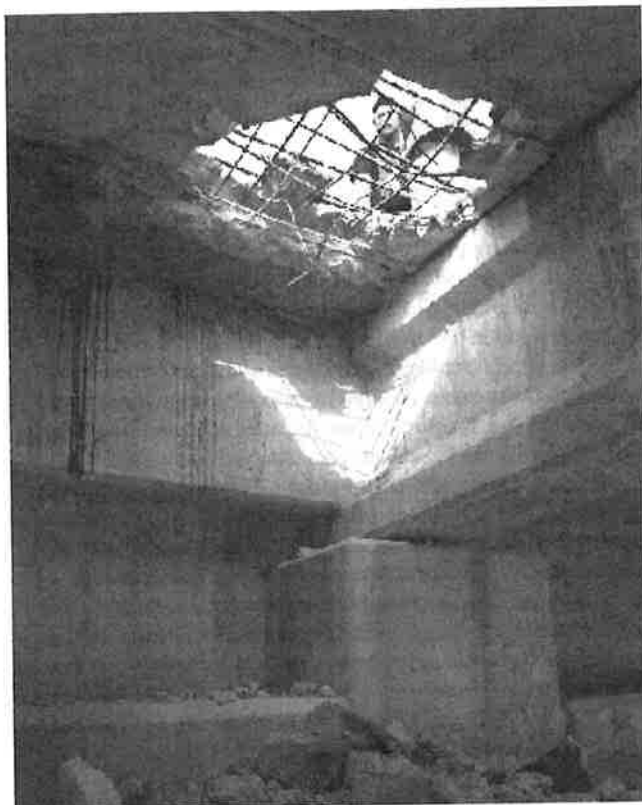
FIGURE 3 Failed panel on Bridge No. 170086: (a) View 1 and (b) View 2. (Source: *Sarasota Herald*.)
