REPAIR & REHABILITATION OF ROB NANDNAGRI FLYOVER (at Road No. 68), DELHI

CONDITION STATUS REPORT AND REMEDIAL MEASURES ON NANDNAGRI FLYOVER (AT ROAD No.68) - DELHI

CONSTRUMA CONSULTANCY PVT. LTD.

FEBRUARY, 2019

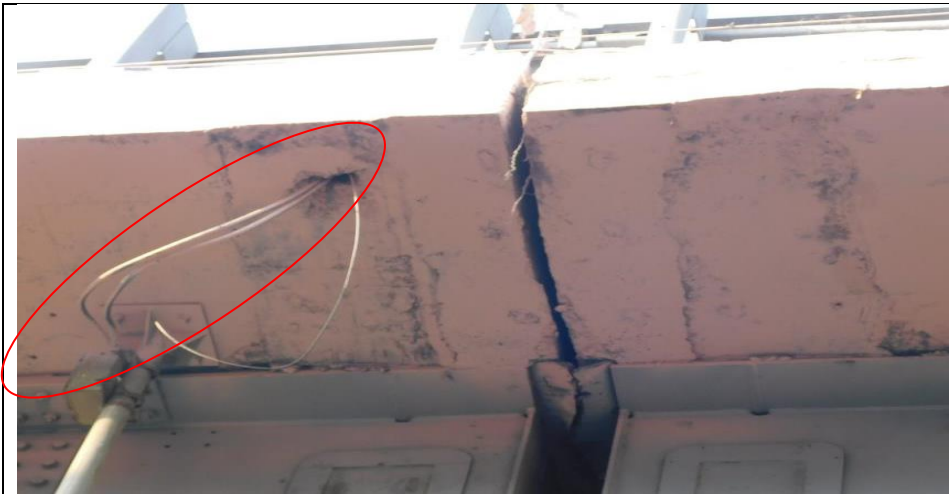
Photo 11

DAMAGES IN BEARING STRIPS

P8-P9

Panel 28

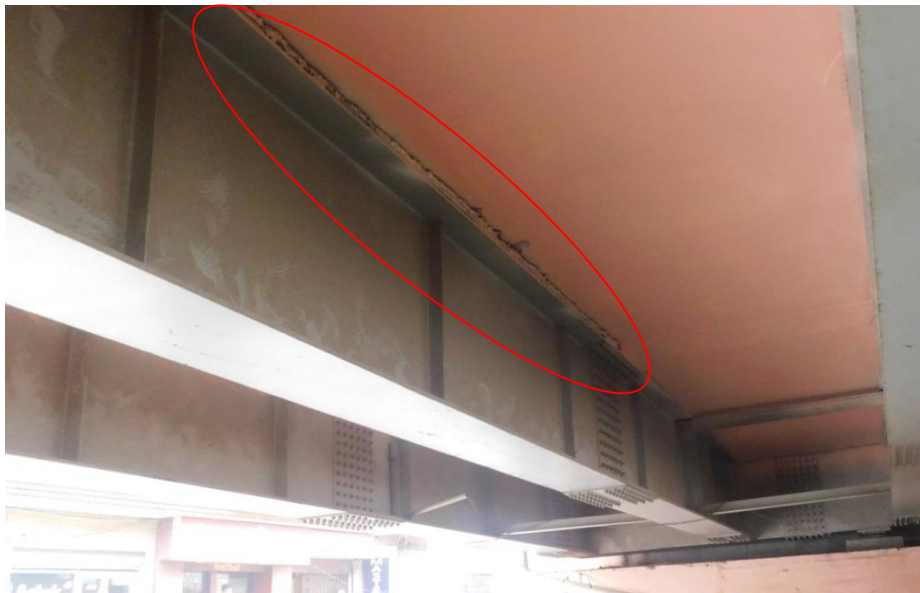
Photo 12

A1 P1

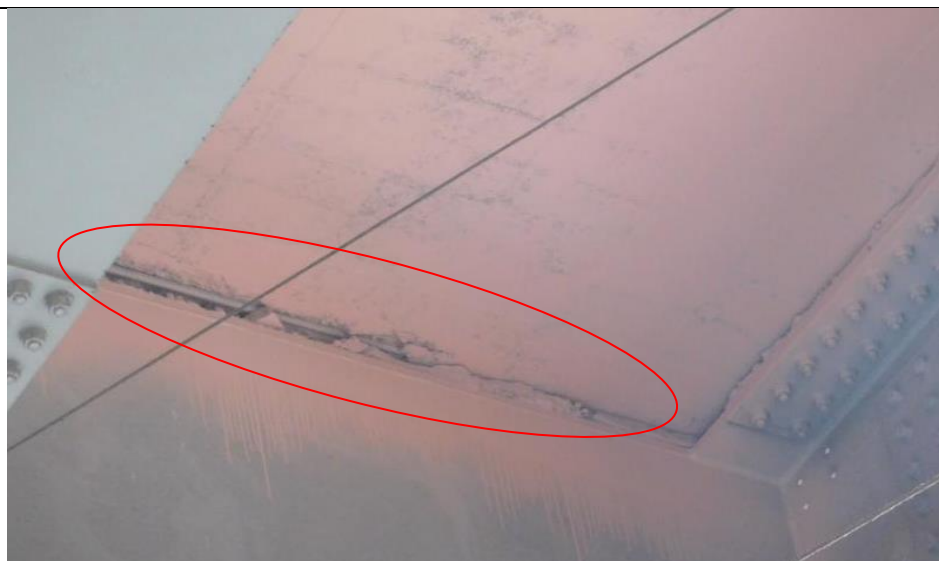
Photo 14

P10 P11

Panel 13

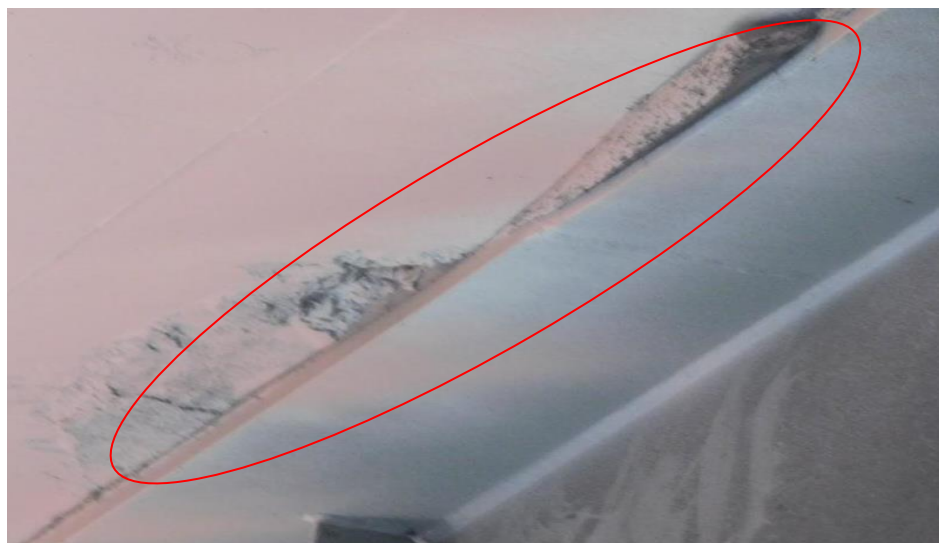
Photo 16

P4-P5

Panel 25

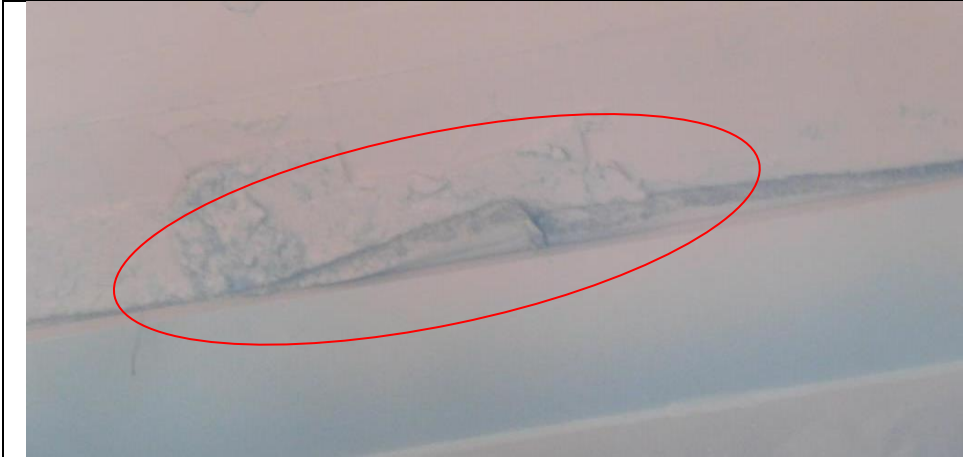
Photo 17

P8-P9

Panel 13

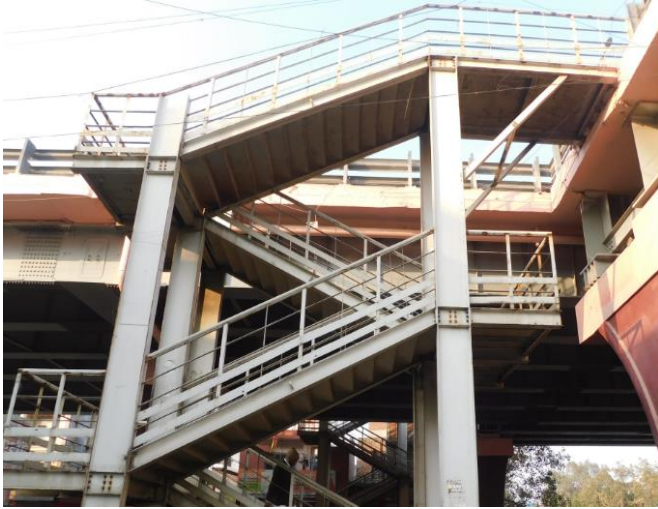
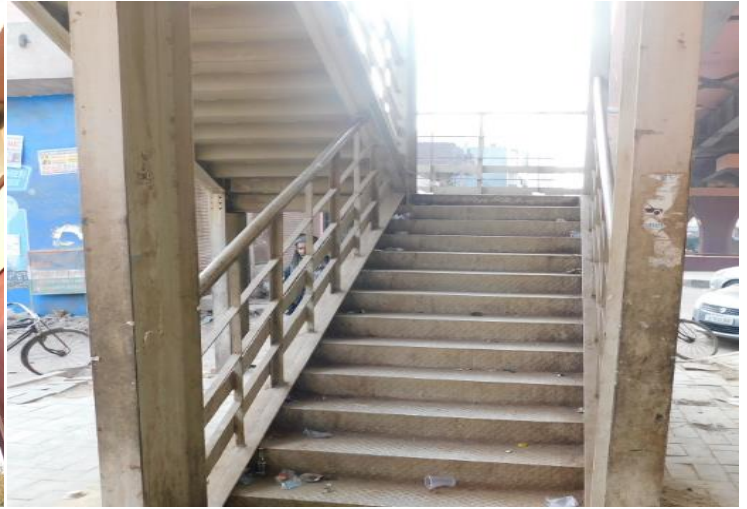
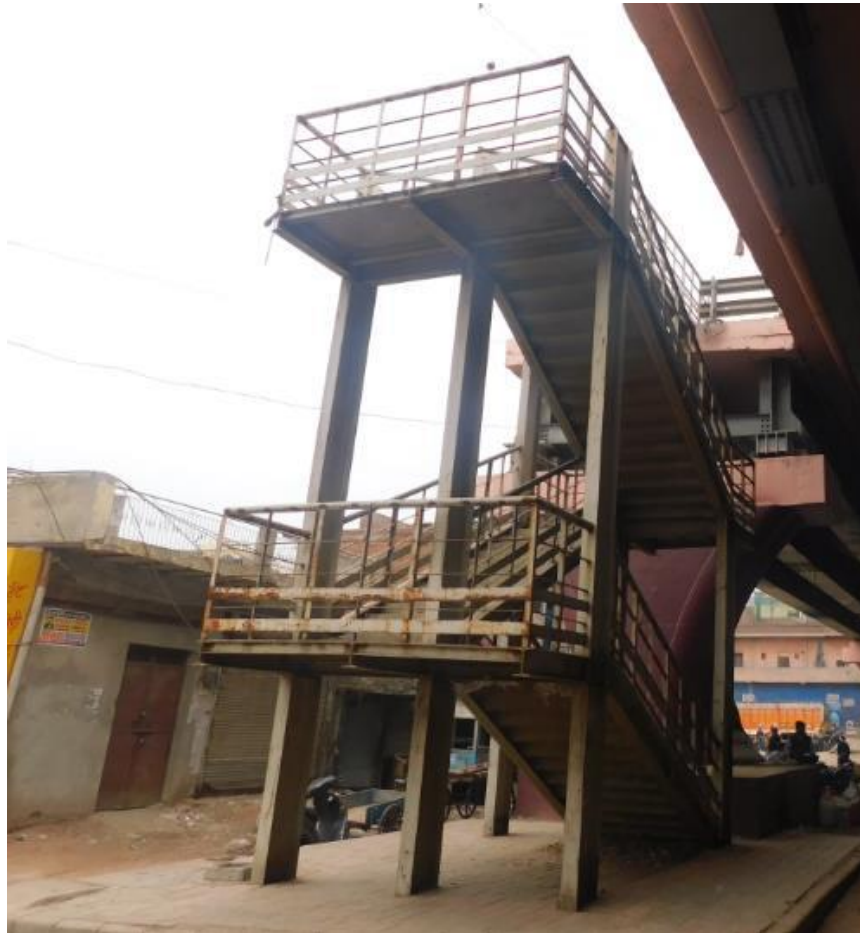
Corrosion and paint failure noticed on Steel Staircases

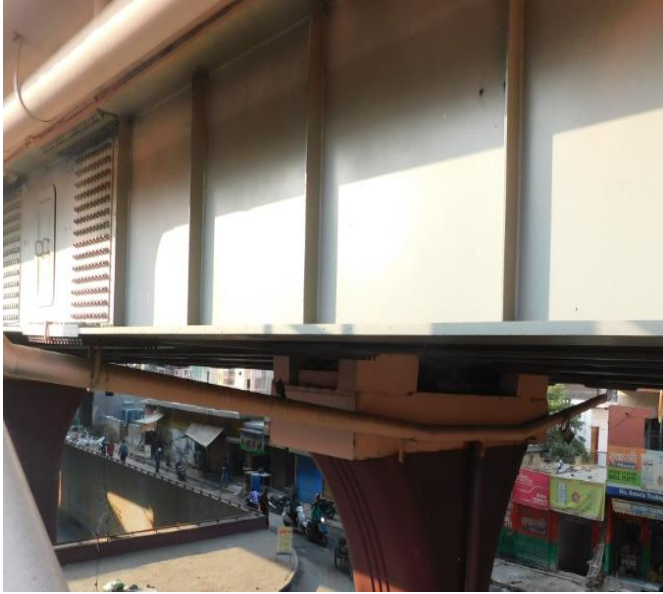
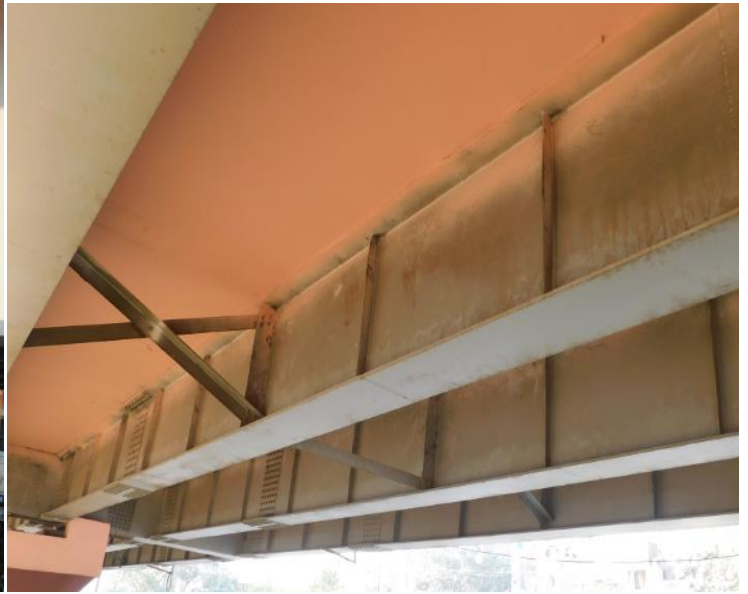
No paint peeling off, **No** paint bubbled and **No** corrosion noticed on web, flange and bracings with diaphragms in steel superstructure
HSFG bolts are in tight and showing no sign of corrosion are observed.

10. **Steel Girders:** The steel girders appeared to be in excellent condition with no undue changes in profile and alignment due to live load over time or as an initial construction defect. They are functioning as designed and installed. All stiffeners, bracings and diaphragms are in excellent condition. Nowhere is any loss of cross section noticed in steel girder, stiffeners, bracings and diaphragms i.e. their current day load carrying capacity of steel grillage is as per original design with no reduction due to any thickness loss on account of corrosion. *(Refer Photo No.21 to 24)*

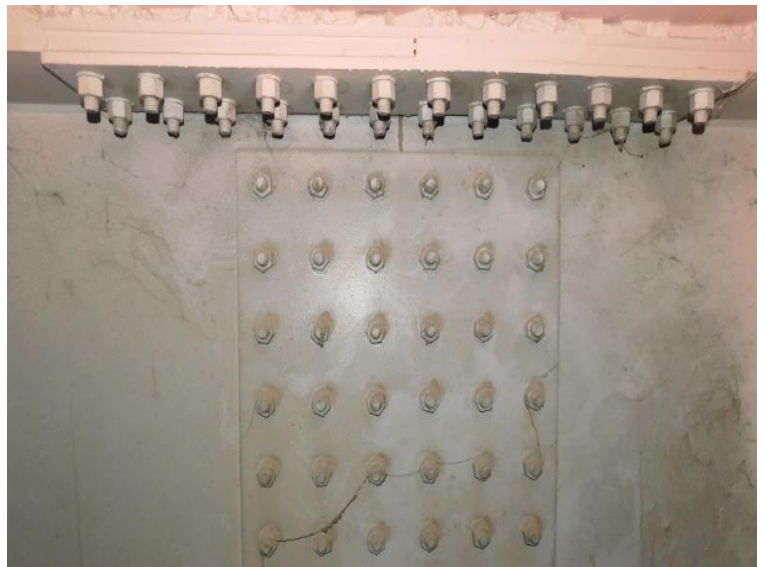
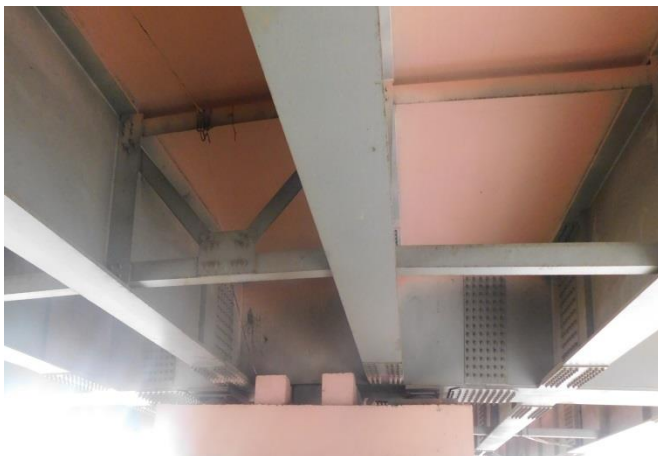
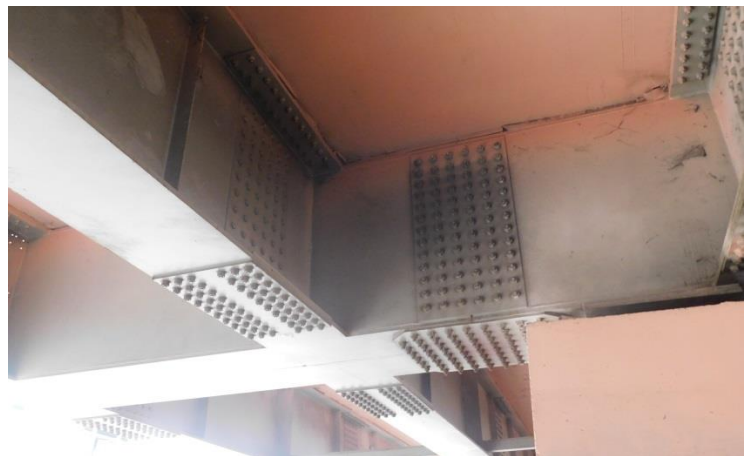
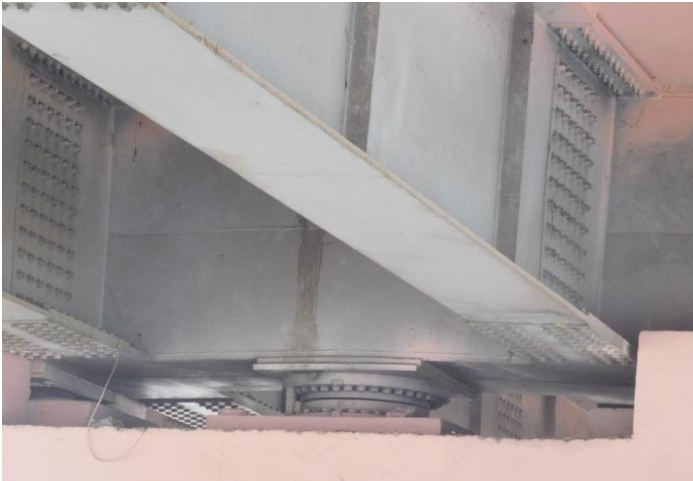
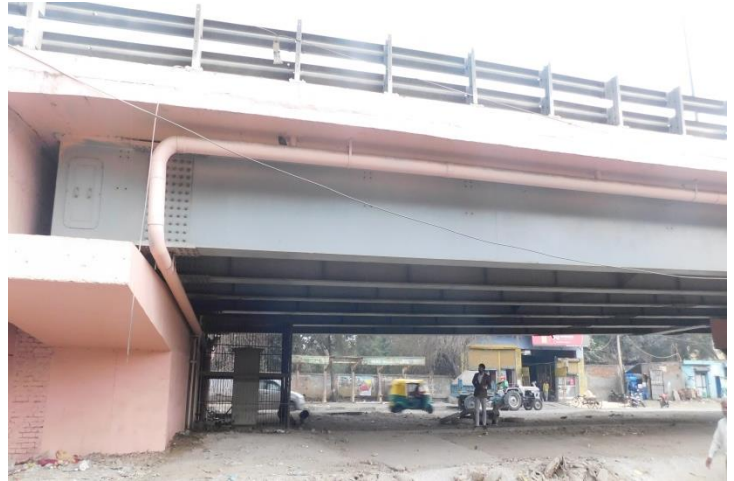
Photo 23.a) End Diaphragms with no distress

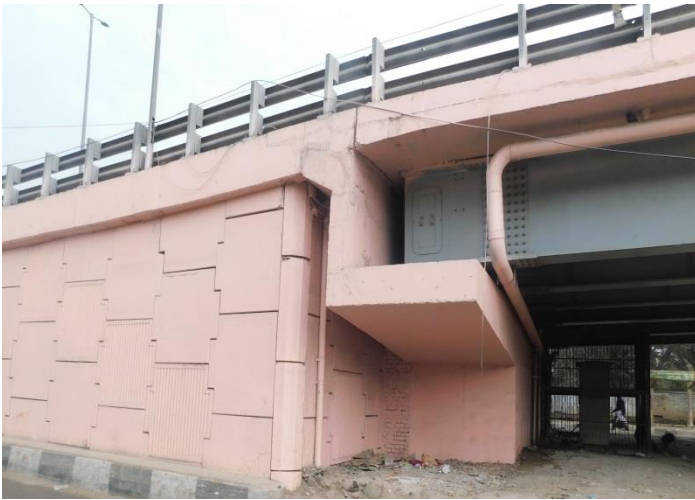
Photo 32. Outer side of Abutments

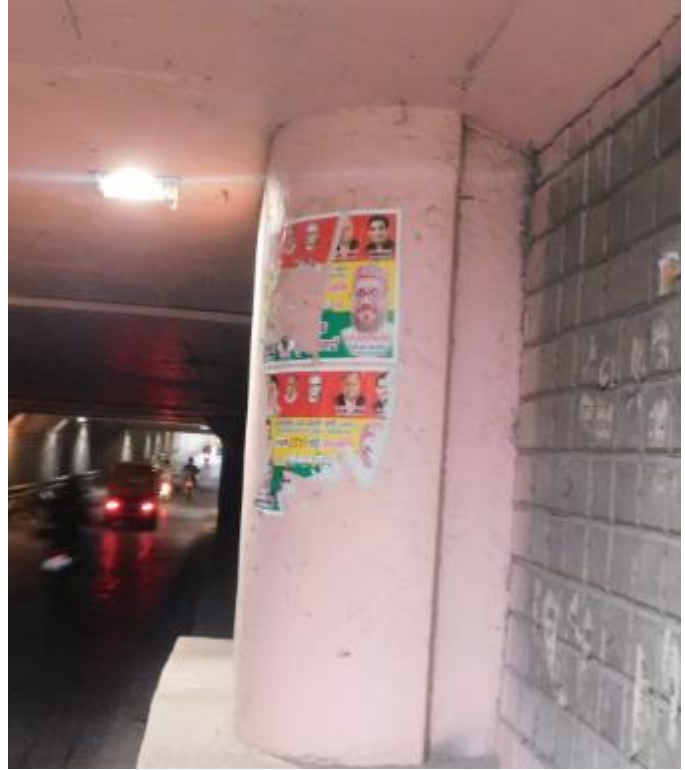
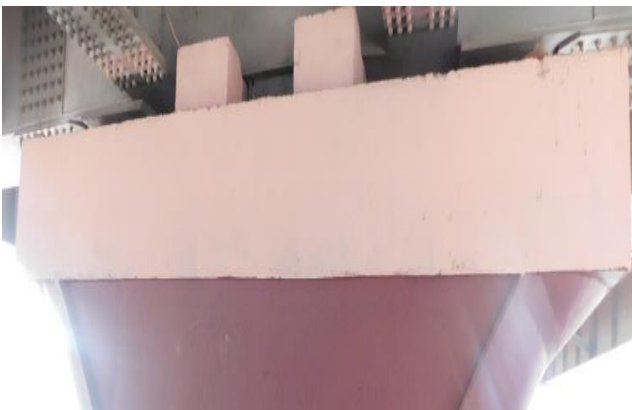
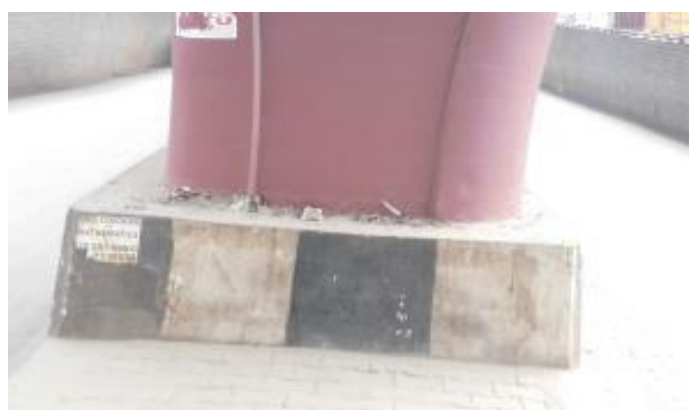
5. **Piers:** No major distress on the pier such as structural cracking or major spalling or corrosion of reinforcement is observed. *(Refer Photo No.35 to 38)*

6. **Piercaps:** In very few piercaps, some minor spalling of concrete and honeycombs (minor) is noticed. They are not a cause for alarm and are easily repaired by local patch work. *(Refer Photo No.35 to 38)*

7. **Pedestals:** Pedestals are in excellent condition with no distress. *(Refer Photo No.35 to 38)*
8. **Bearings:** Bearings are in excellent condition showing no sign of any corrosion or any undue loss of alignment/ settlement. *(Refer Photo No.39 to 42)*

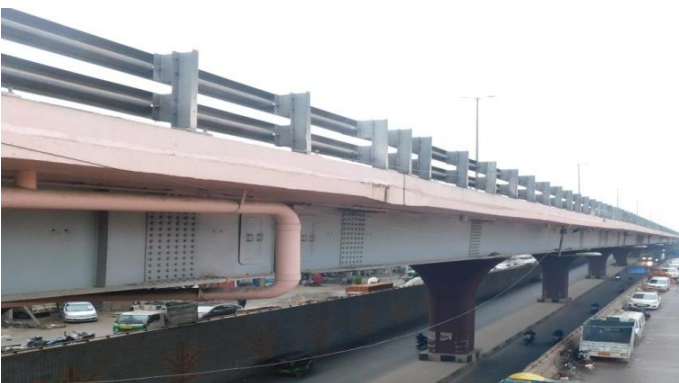
Photo 47. Outlet pipes are not connected to the downtakes

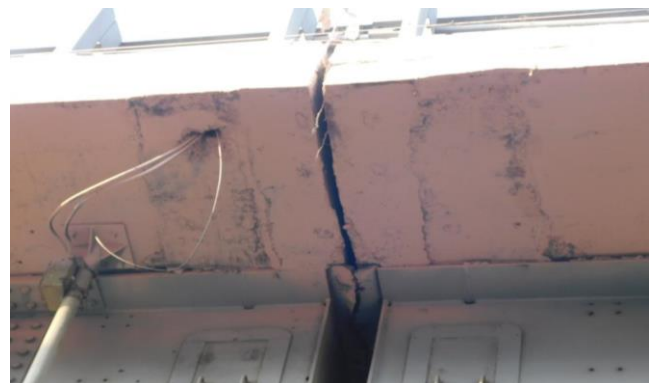
Photo 47.a) Drainage pipe missing.

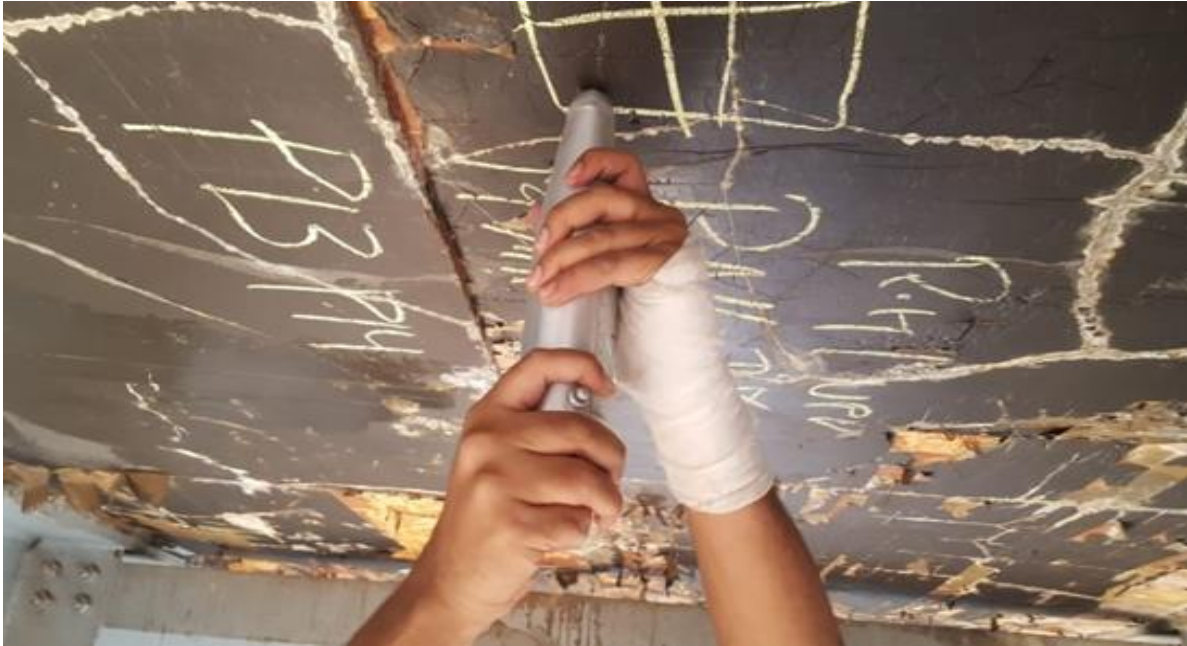
Photo 70. Rebound Hammer Test

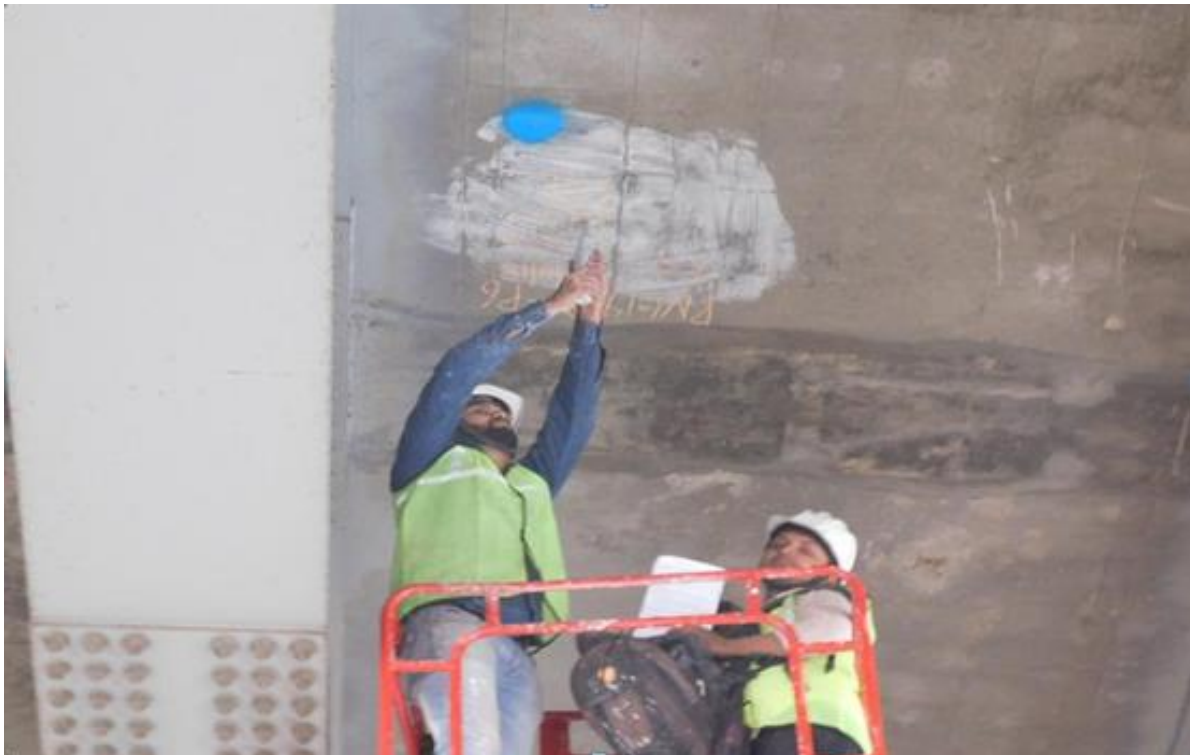
Photo 71. Rebound hammer Test on Panel

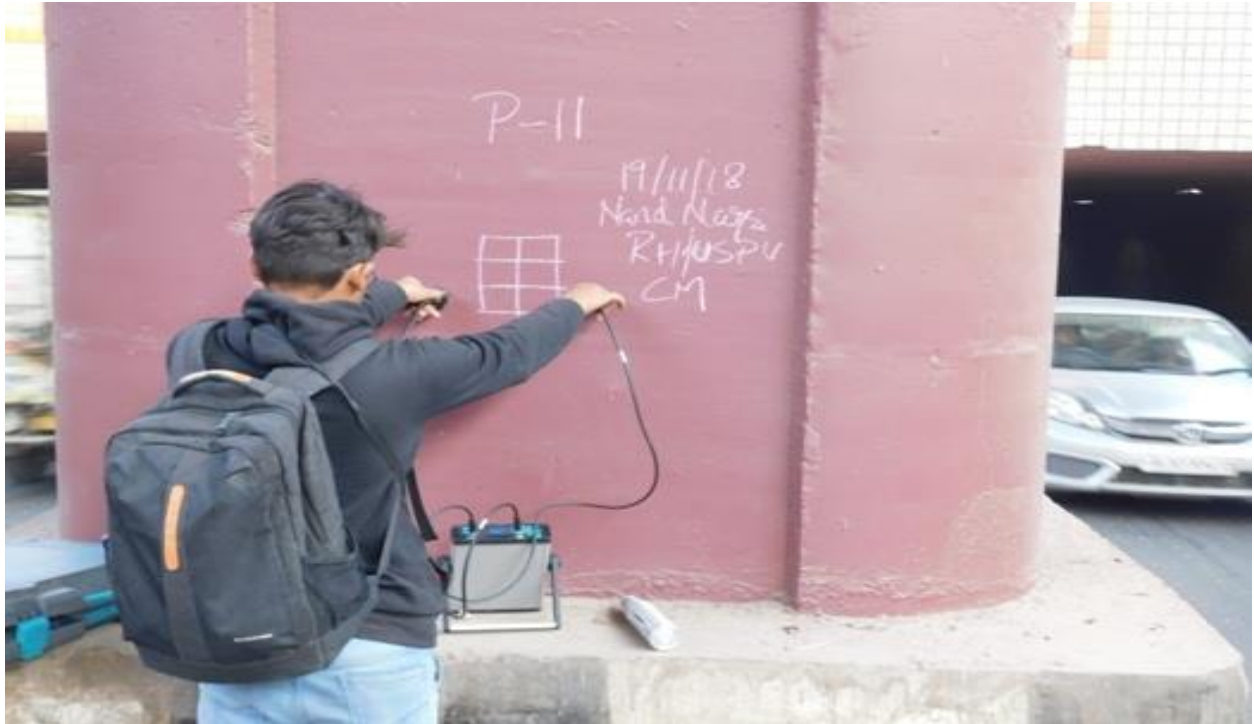
Photo 72.USPV Test on Pier P11

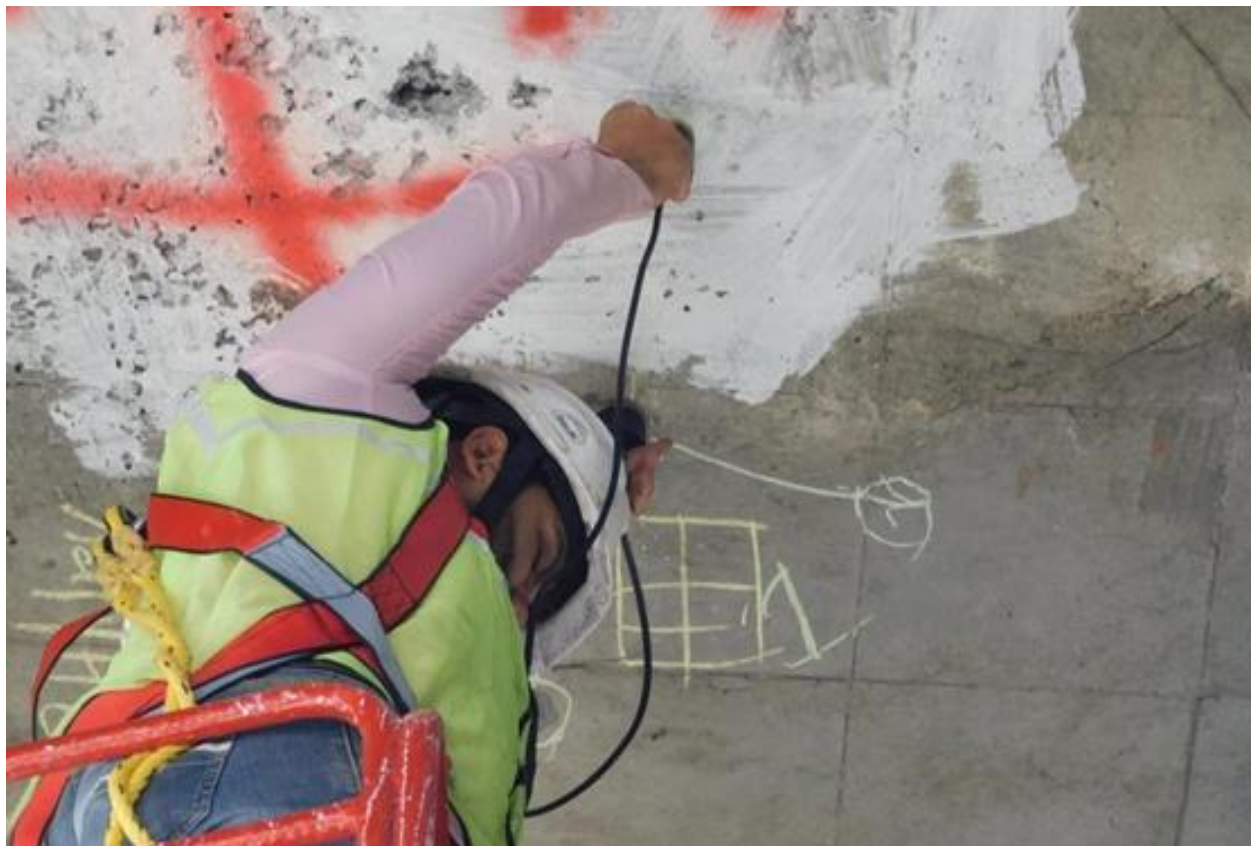
Photo 73.USPV Test on Panel

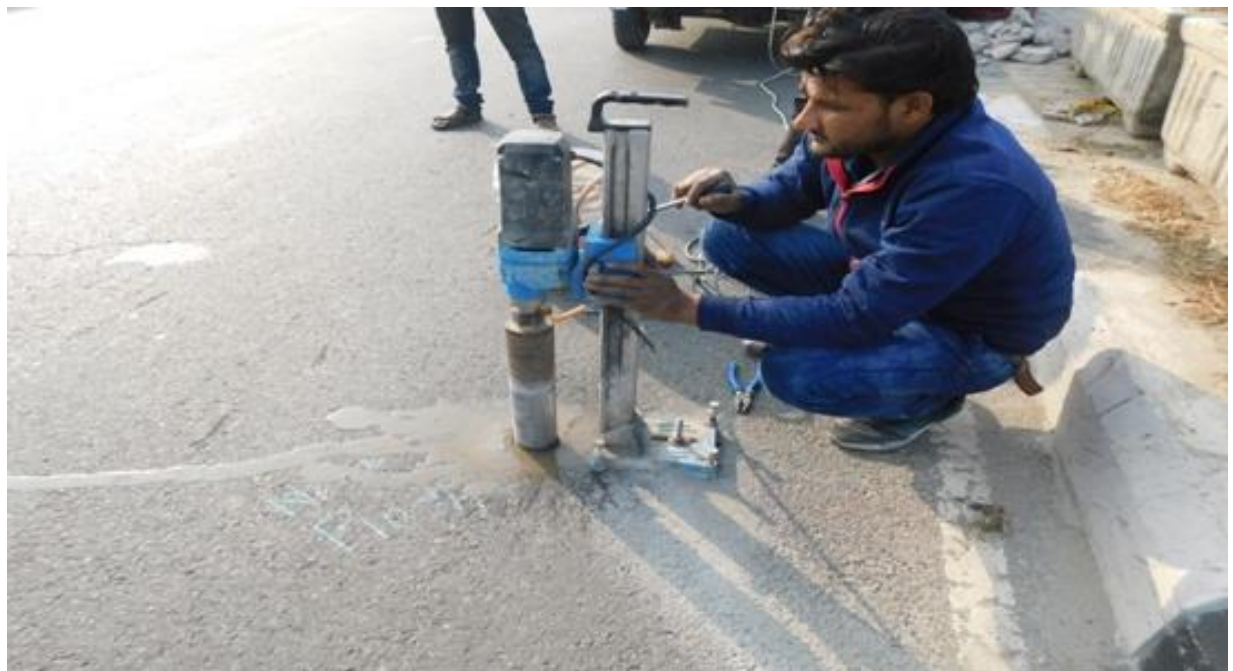
Photo 75.Core sample is being extracted for compression test

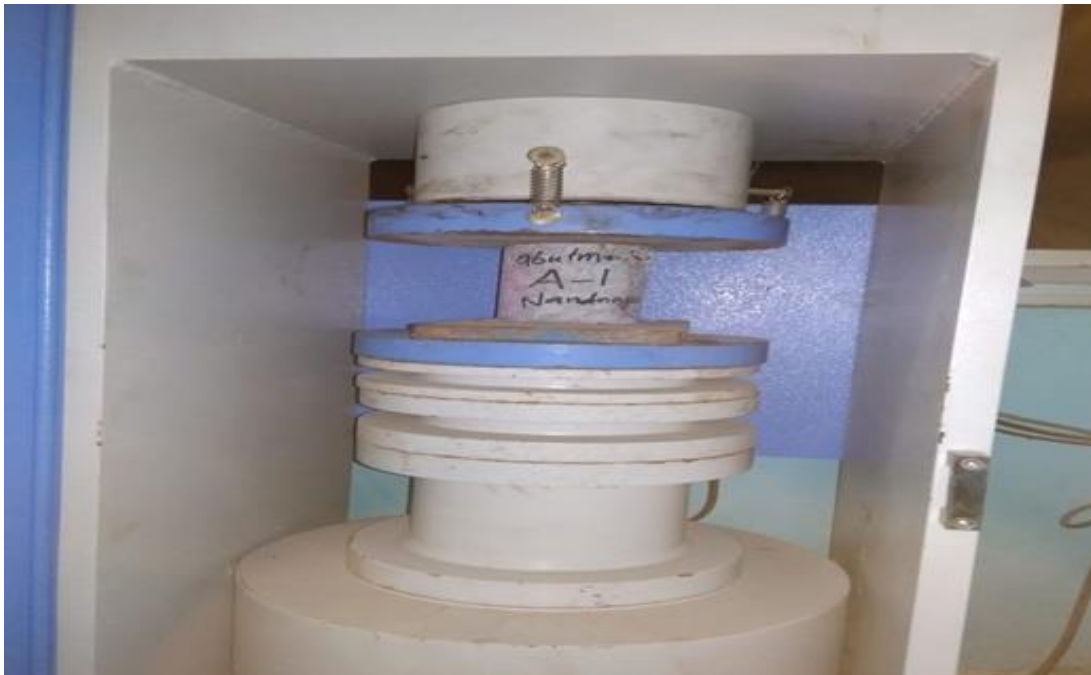
Photo 76. The core sample is placed and tested using Compression Testing Machine

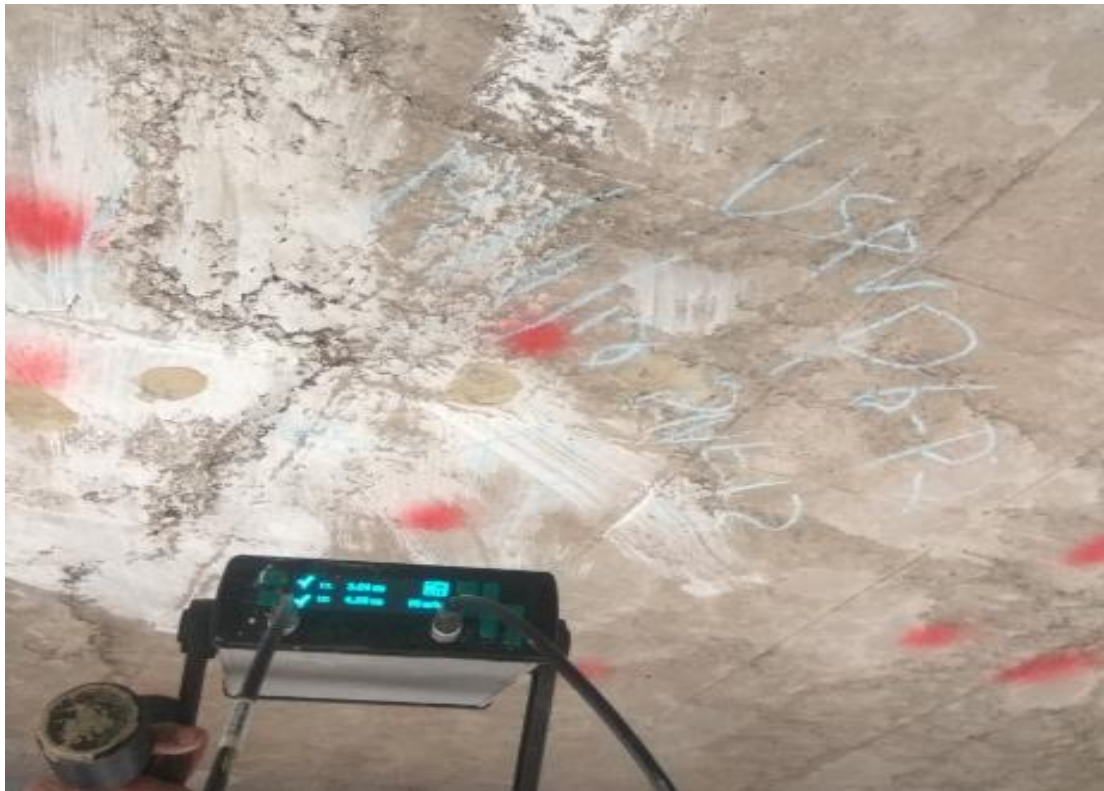
Photo 77. Crack pattern analysis using the USPV

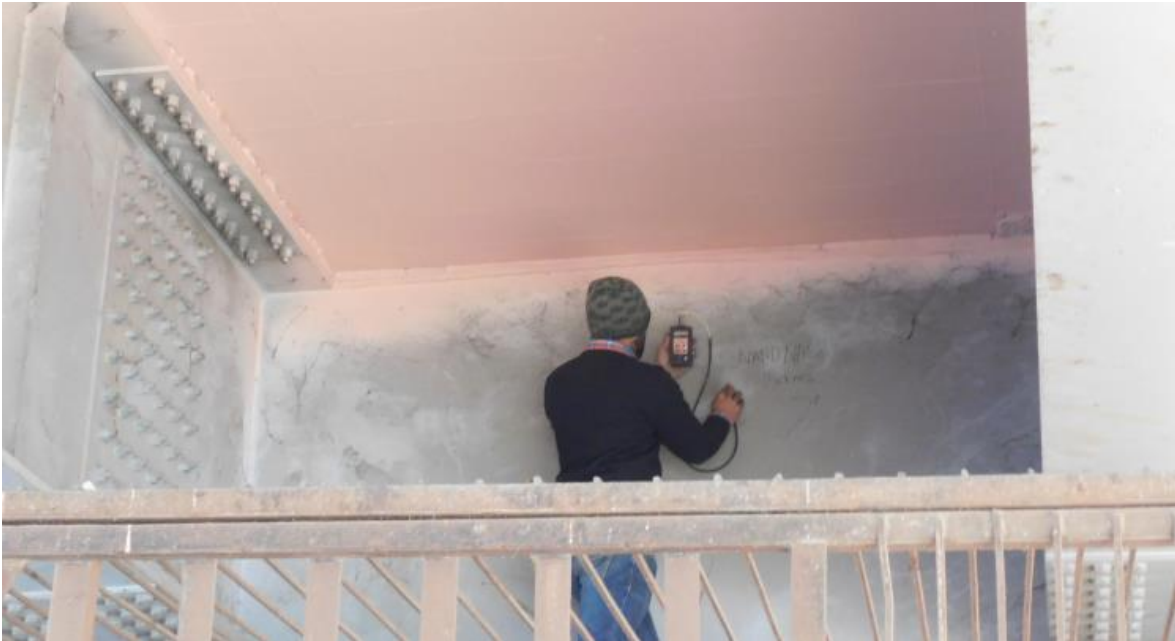
Photo 78. Thickness Testing on steel girders and diaphragms

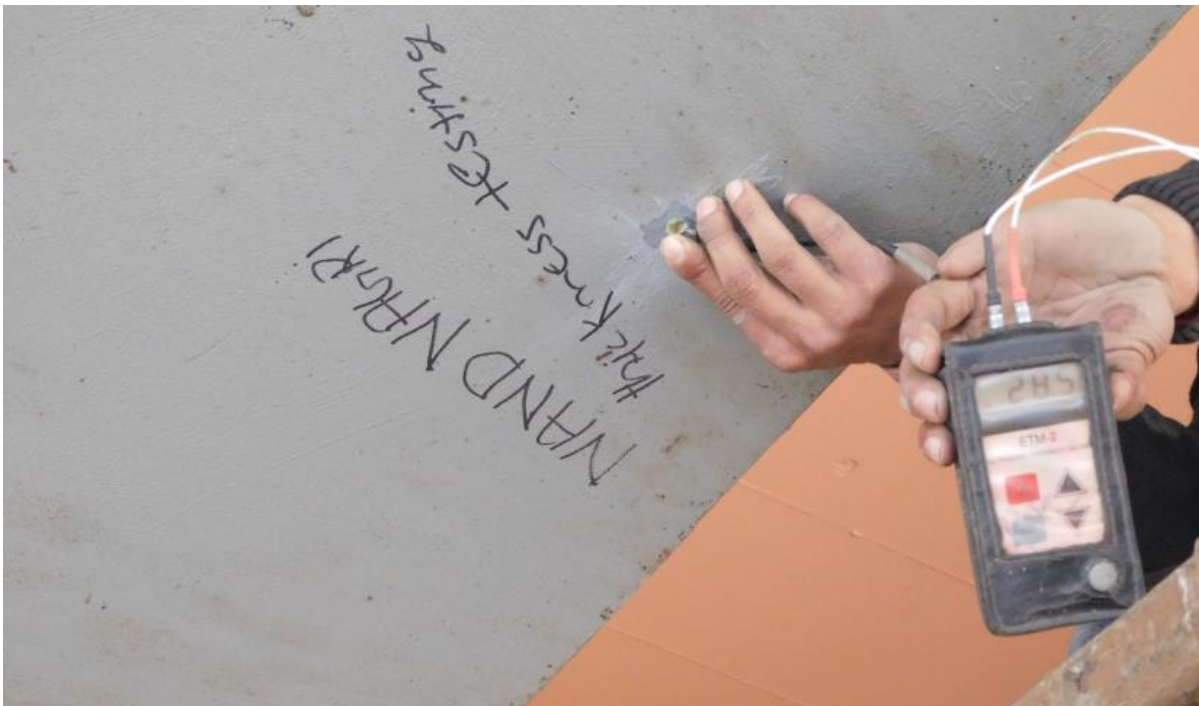
Photo 79. Thickness Testing on steel with Ultrasonic thickness gauge

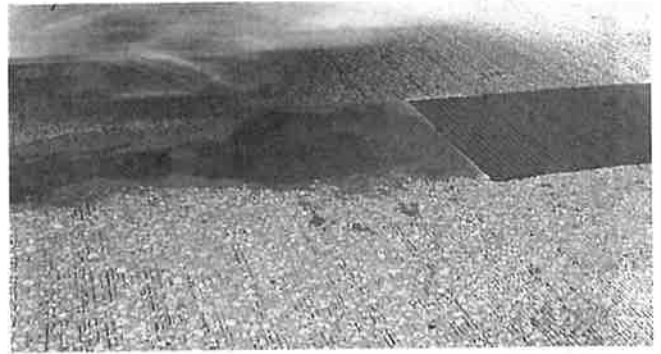
To patch with asphaltic concrete is not labor-intensive and can be done in a matter of minutes with minimal disruption to the traveling public. It is also an inexpensive procedure. The maintenance crew closes a lane temporarily, if necessary; cleans debris out of the spall with hand tools; and patches the spall with a ready-mix bag. The asphalt patch is intended to minimize immediate danger to the motoring public as well as to avoid an increase in the size and intensity of the spall (Figure 5).

This repair method was never meant to be a permanent solution. The maintenance crew was to return within a week and perform a permanent repair in accordance with the policy of the District Structures Maintenance Office. Sometimes, however, other priorities meant that these temporary patches remained in place for extended periods of time. This practice proved to be detrimental, especially in cases in which asphalt was used to patch spalls inside or adjacent to a deficient repair. Rather than distributing the load evenly, the flexible asphalt, which had negligible compressive strength, would pound the precast panel below the surrounding CIP section, which resulted in an increase in the area and depth of the spalls and in the cracks of the precast panel (15).

In the worst cases, the pounding punched a hole through the lower deck panel. Six of the seven punching failures (Table 1) occurred after rainfall. Water filled the crevices between the panel and patch material in which subsequent wheel loading caused pumping action between the asphalt and the precast panel until failure (15). Four

FIGURE 5 Spalls patched with asphalt and walking spalls.

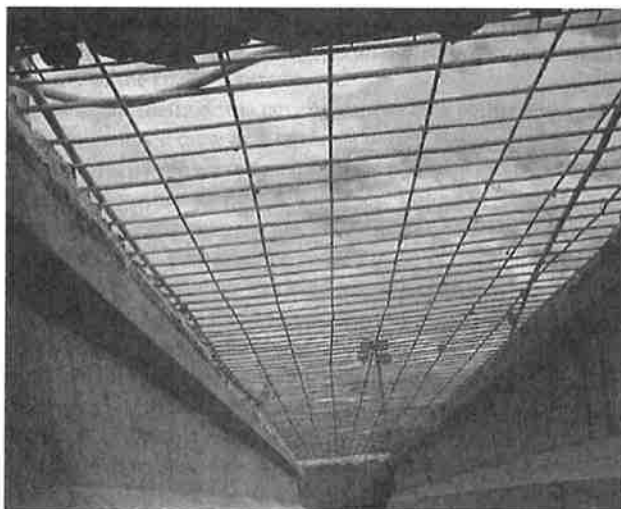
FIGURE 9 Full-depth bay replacement repair: (a) existing and (b) new steel.

Full-depth bay replacement is the most effective repair method for deficient precast deck-panel bridges (Figure 9). As stated previously, it is the directive of the District Structures Maintenance Office to use this method for all permanent repairs. At a minimum,

When only one bay is replaced, the CIP concrete and precast panel are demolished, which leaves only the reinforcing steel grid originally within the CIP section for continuity. A new bottom steel mat is designed (Figure 9) and placed as an alternate to the precast panel. A standard compression test is performed to verify that the concrete has gained the required strength before the bridge or repaired area is opened to traffic. None of the failures reported in Table 1 occurred on decks that had been repaired by full-depth bay replacement.
